How is stormwater pollution quantified?

Objectives

- The purpose of this research was to measure the variability associated with land surface covers for different land uses in a large urban area in the state of Alabama and show how this information affects runoff quality and quantity.
- Little Shades Creek watershed and 5 other highly urbanized drainage areas situated in Jefferson County, AL (around Birmingham) were surveyed in detail to determine the actual development characteristics and their variability

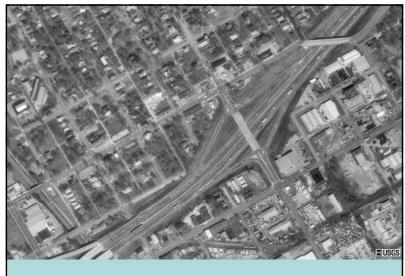
Example of 1 m monochromatic aerial photograph (USGS photo)

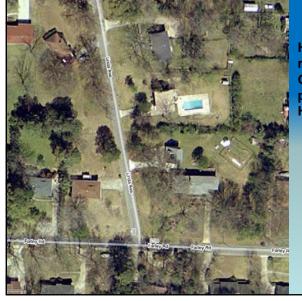
Higher resolution Google aerial photo for Hoover, AL
