# Monitoring Trends of Regulated Outfall Water Quality over Twenty-Five Years in Response to Diverse Set of Site Management and Stormwater Controls at a Historical Industrial Site

## **Abstract**

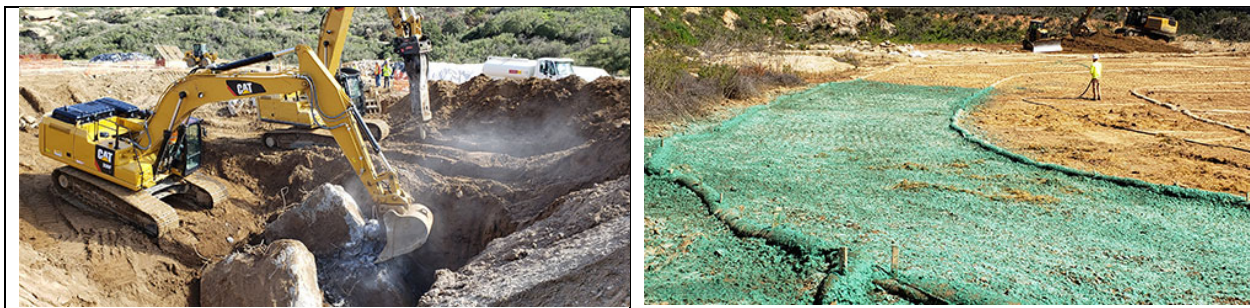
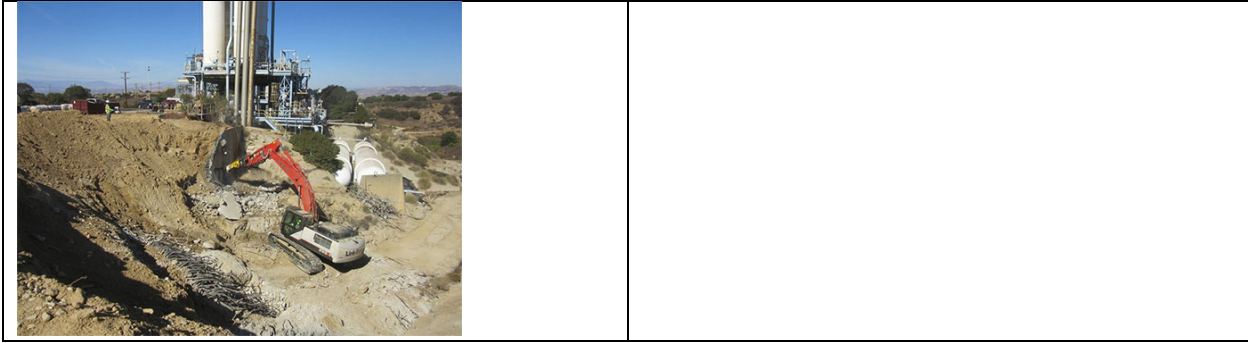
Figure 2. Photos of Phase 4 demolition from NASA website (NASA b)

- Phase Four: Phase 4 demolition included approximately 80 ha (200 acres), involving the LOX area in NASA Area I and the Bravo Test Stand 3 area in NASA Area II. Phase 4 demolition focused on the removal of a subsurface concrete slab that remained in Area I LOX, as well as the retaining wall, concrete foundation, and spillway of the former Bravo Test Stand 3.

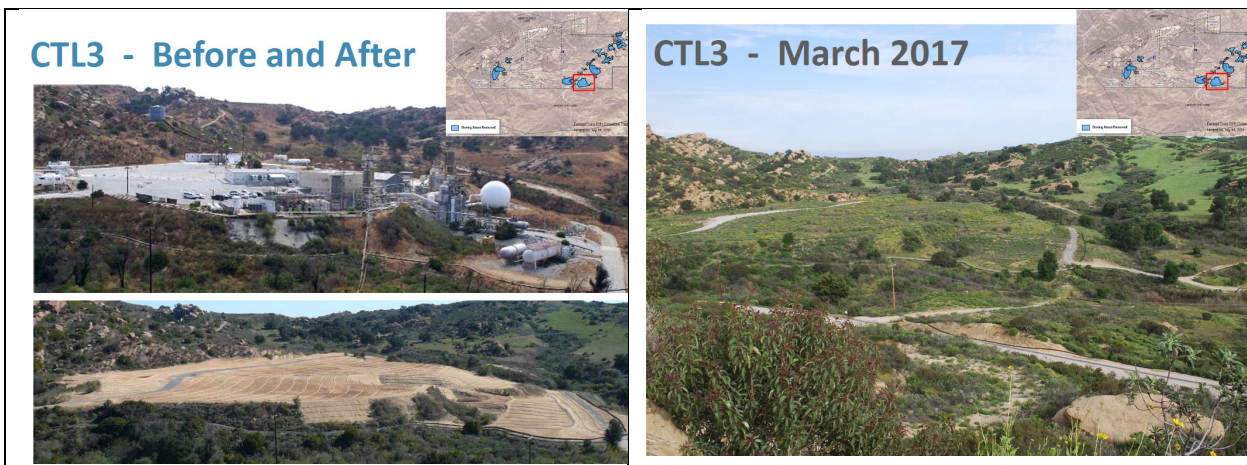
Figure 3. Building and asphalt demolition on Boeing property.

The following map shows these demolition areas. Also shown on Figure 3 are pre- and post-demolition photographs at several of these locations.

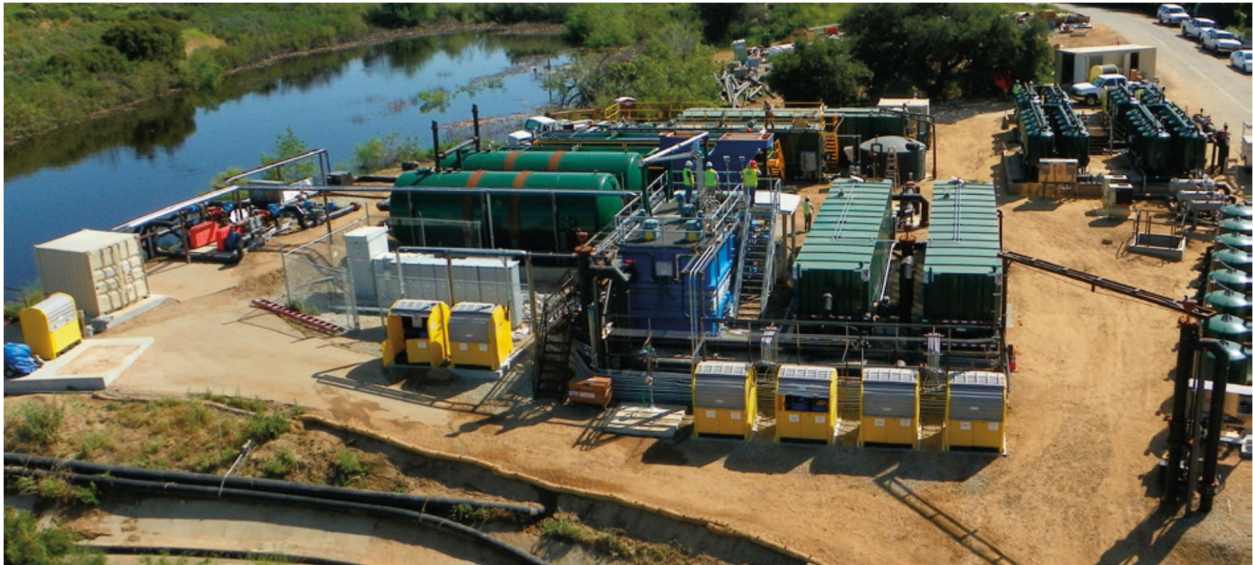
**Figure 8. Outfall 018 Silvernale stormwater treatment system and adjacent storage pond completed in 2011.**

Besides the natural runoff in the watershed above Outfall 018, most of the stormwater from the small northern outfalls (003 through 007, and 010), along with runoff from a portion of the paved helipad above Outfall 009 (Figure 9), is pumped to the Silvernale pond and treatment system. Flows greater than the local storage and transfer capacity at the northern outfall locations are discharged at the northern outfalls, which also include media bed filters.

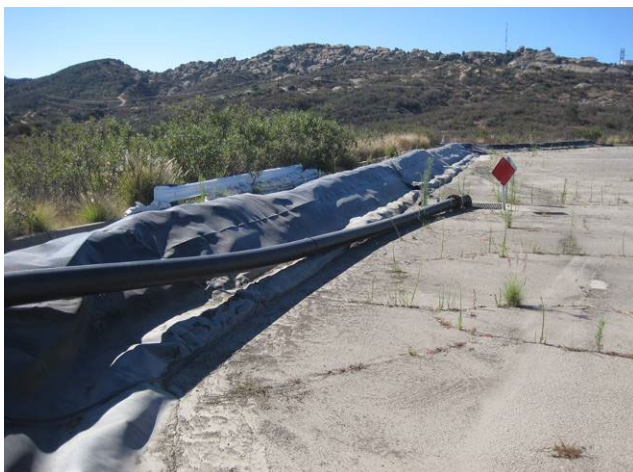
**Figure 9. Berms and pumps at helipad used to divert flows to Silvernale stormwater treatment system began in 2011.**

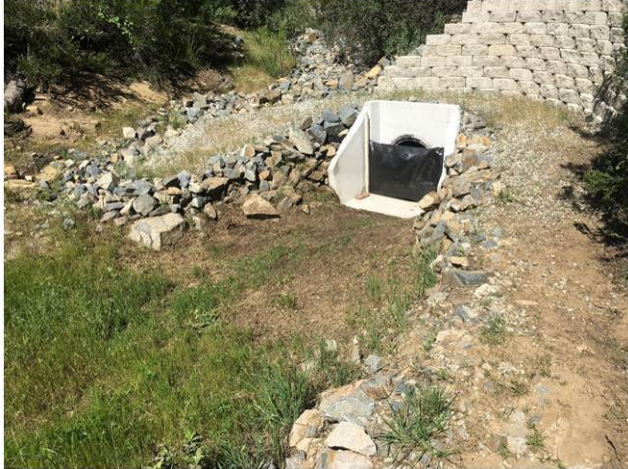
**Figure 16. Culvert modifications installed in 2009.**

“Culvert modifications” (CMs) were installed early in the process in 2009 and 2010 as these could be installed quickly. The CMs are retrofits of the existing culverts and include headwalls with weir boards that span the entrance to each culvert that divert stormwater through treatment media (mixture of GAC, zeolite, and sand). Twelve culvert modification systems have been installed at SSFL.

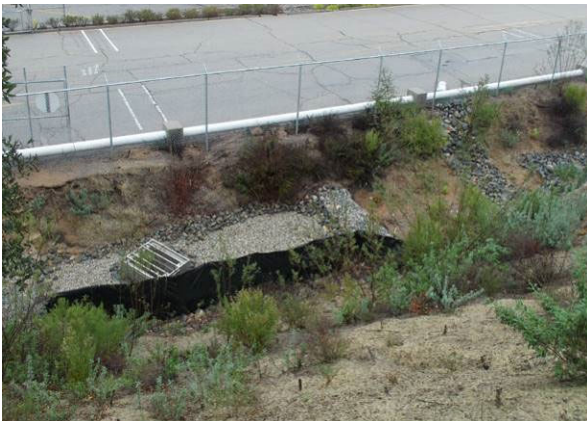
**Figure 17. B-1 Sedimentation basin and media filter installed in 2012.**

Upstream of an existing culvert, a media filter with sediment forebays was installed in 2012 to capture stormwater from the adjacent hillside and roadway. The media filter consists of a 10 cm (4 in) layer of gravel on the surface, underlaid by a 45 cm (18 in) layer of filter media (sand, GAC, zeolite), which are on top of a 10 cm (4 in) perforated pipe surrounded by gravel. The underdrain conveys the treated stormwater to a riser overflow structure where it is discharged to the Northern Drainage. A detention basin was also installed upstream to provide flow equalization along with additional settling and pretreatment of hillside flows before the media bed.

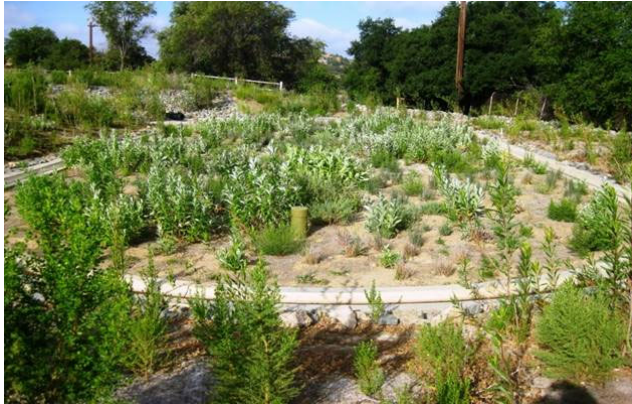
**Figure 18. Lower parking lot sedimentation basin and biofilter installed in 2013.**

consists of a 10 cm (4 in) layer topsoil/compost vegetative support layer, 45 cm (18 in) layer of treatment media (fine filter sand, GAC, zeolite), 30 cm (12in) gravel layer and a 20 cm (8 in) underdrain. A plant growth pilot study identified native plants that could grow in the treatment media and survive alternating submerged and long-duration dry conditions.

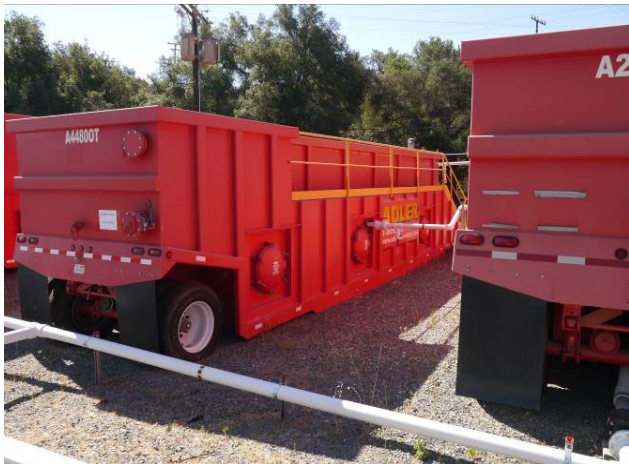
**Figure 19. ELV treatment train installed in 2013.**

The ELV (historical NASA extended launch vehicle research area) treatment train was constructed in 2013. The stormwater captured in the sump is pumped into two open top portable sediment tanks having floating tube settlers. The sediment tanks drain by gravity to an additional open top portable media filter tank, which percolates stormwater through 45 cm (18 in) of treatment media (mixture of sand, zeolite, and GAC) before discharge through an underdrain pipe.

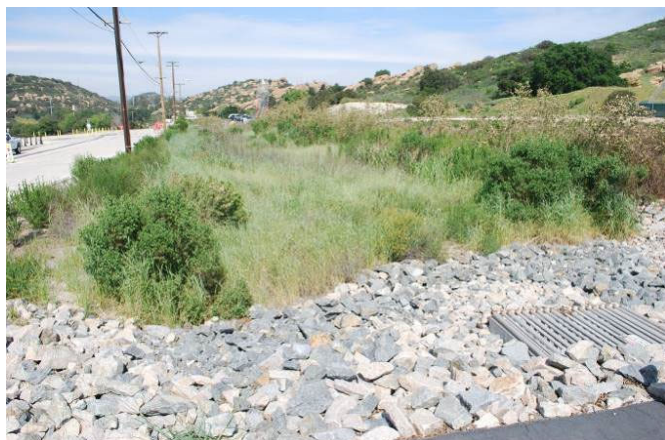
**Figure 20. Detention bioswales installed in 2015.**

before the lower lot biofilter system (which contains the specialized treatment media) after the initial lower lot flows are treated. Excess water that cannot be further treated by the biofilter (during periods of high flows and when the treatment system capacity is full) is directly discharged to the Northern Drainage. Each detention bioswale drains through an outlet pipe, controlled by two orifices sized to drain the system within 72 hours.

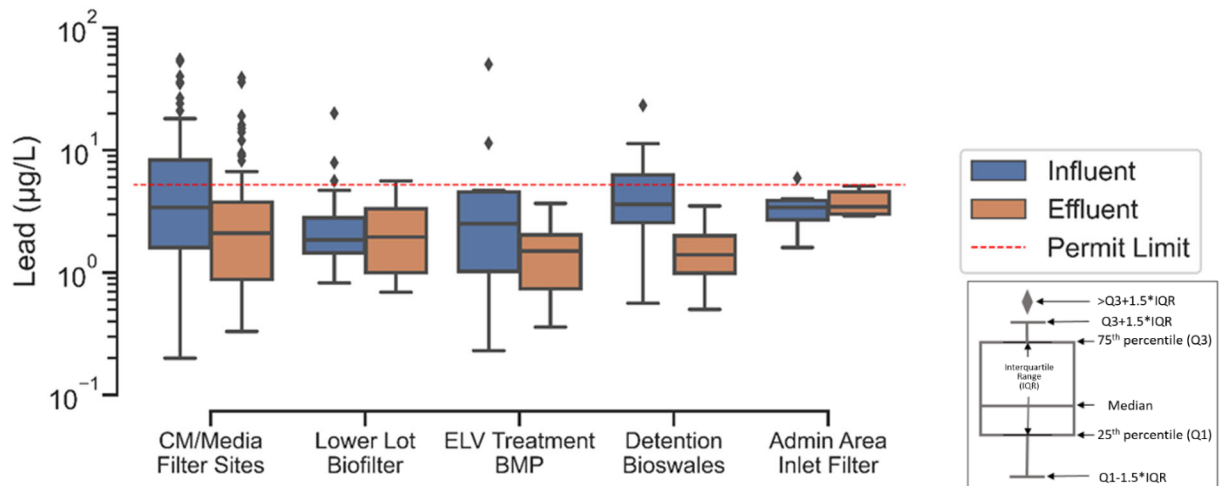
**Figure 22. Stormwater control performance – Influent/effluent box plot for lead, 2009-2022.**

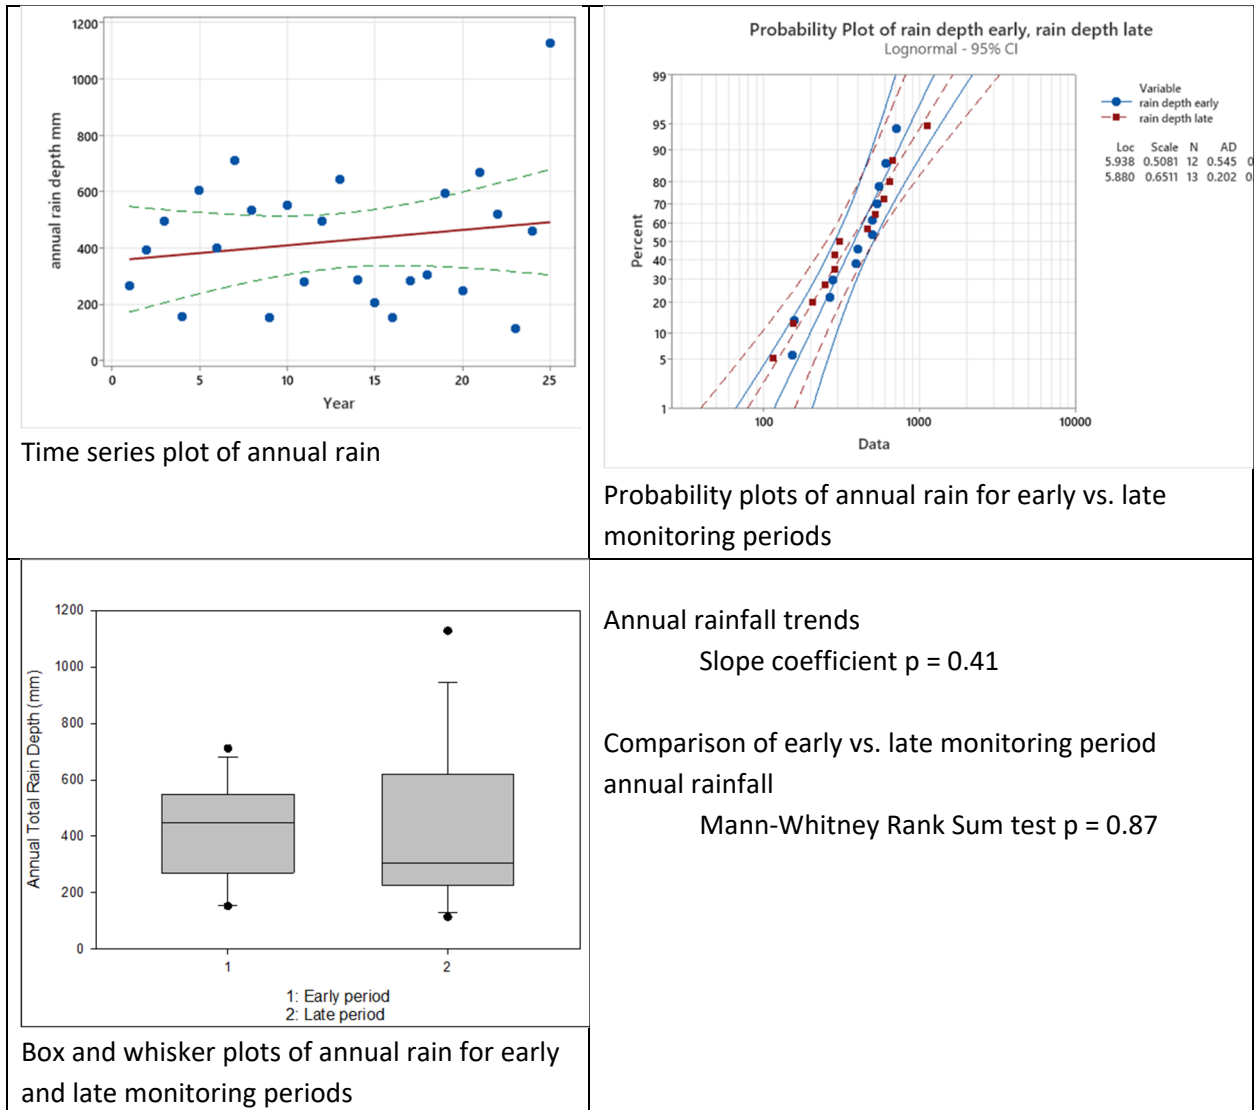
Figure 24. Time series, probability, and box and whisker plots of annual rainfall amounts before and after interim contaminated material removal and stormwater management at SSFL.

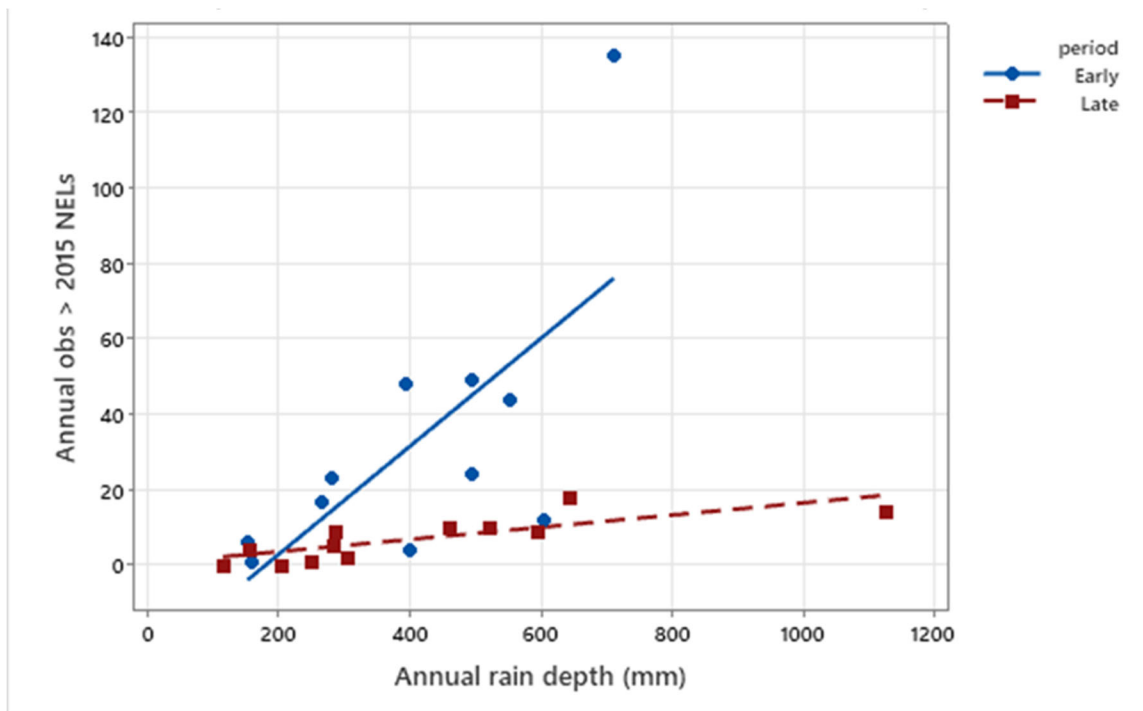
Figure 25. Annual sum of observations greater than the 2015 NELs compared to annual rain depth (mm) before and after interim contaminated material removal and stormwater management at SSFL, excluding two years with fires.

Figure 25 shows scatterplots of the numbers of concentration observations that were greater than the 2015 NELs per year vs. annual rainfall, excluding the two years having large fires. Both plots show significant relationships with increasing observations greater than the 2015 NEL values with increasing annual rain amounts ( $p$  of the regression slopes were both  $< 0.02$ , with insignificant intercept terms). However, the early period before the interim contaminated material removal and stormwater management at the site had an average slope coefficient more than eight times greater than the slope coefficient during the later period (early period slope term: 0.14 relative slope with a 95% confidence interval of 0.03 to 0.26, and later period slope term: 0.016 relative slope with a 95% confidence interval of 0.007 to 0.025).

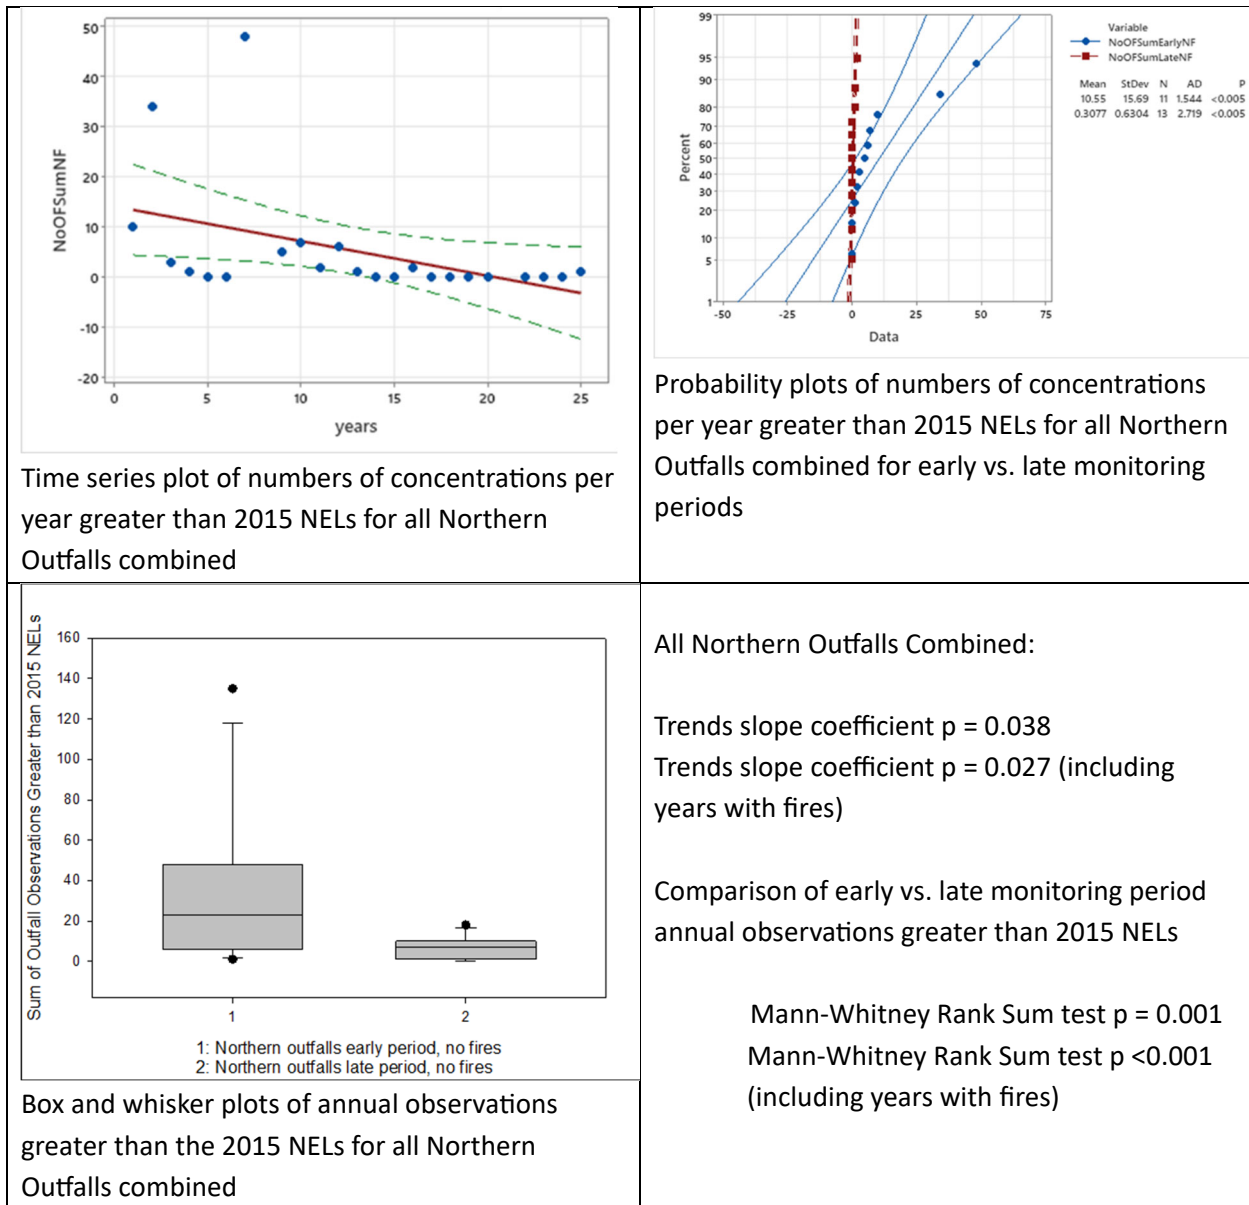
Figure 28. Time series and probability plots for numbers of high concentrations per year at SSFL Northern Outfalls.

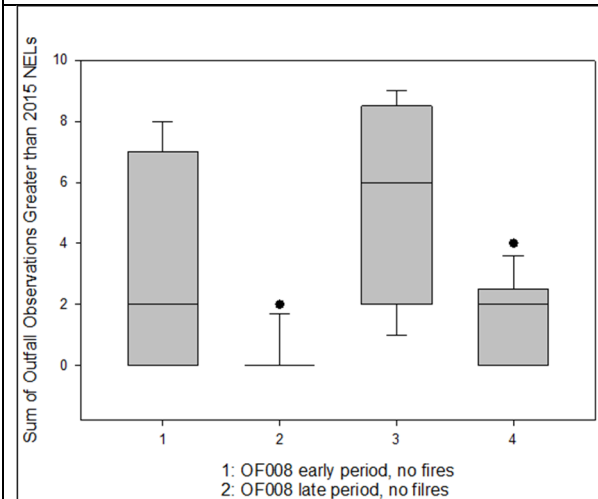
Box and whisker plots of annual observations greater than the 2015 NELs for Outfalls 008 and 009
