WATERSHED INVESTIGATION FOR THE IDENTIFICATION OF SOURCES OF INAPPROPRIATE DISCHARGES

TO THE CRIBBS MILL CREEK.

A THESIS

Submitted in partial fulfillment of the requirements for the degree of Master of Science in the Department of Civil and Environmental Engineering in the Graduate School of The University of Alabama

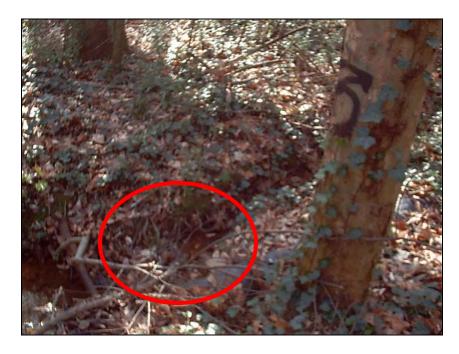
Figure 4.2. Outfall 3

4.2.1. Outfall 3: Outfall 3 is located in a residential area, off 15th Street East in Tuscaloosa, AL. The banks of the creek are characterized by dense vegetation. This outfall is about 2 ft. in width, and is in the form of a stream flowing into the main creek. This outfall is located in the backyard of a quarter acre residence. There has been no indication of inappropriate flows originating from the residence itself. The single stream feeding this outfall was followed till it came to a point where it had two head streams. These head streams are again located in the backyards of residences. The area where the streams flow is characterized by dense fallen foliage and shrubs. Both the streams were followed to the source. Stream A (Figure 4.1) seems to have a very short run before it joins the main stream, and it seems to originate below all the dense foliage, making it inaccessible to verify the source. Stream B was also followed to its source and it also seems to be upwelling from the ground, but very close to a residence (Figure 4.4). Since both these streams showed wash waters at one time or another, it seems logical to conclude that there could be pipes originating from these residences which are covered by the dense foliage, which carry the laundry waters from these houses to the streams. There is also a likelihood of the presence of springs in this area, which contributes to the flow.

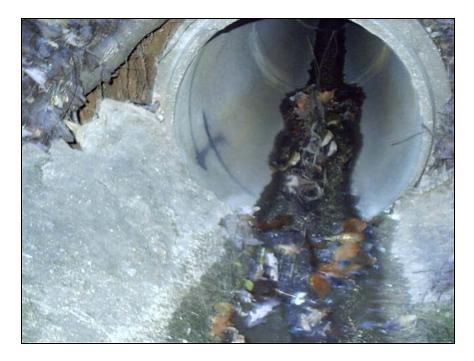
Figure 4.6. Outfall 4

Outfall 4 (Figure 4.6) showed continuous flows and was characterized by the presence of sediment all the time. During the three verification creek walks, all the connecting manholes were sampled and samples were taken separately at each of the incoming pipes, hence if a pipe is coming into a manhole from across the 15th Street, it is so labeled. The layout of the manholes is shown in Figure 4.5. The storm sewer drain flowing into the creek and the manholes were typically 2 ft. in diameter and the incoming sewer pipes were 2 ft. and 9 inch pipes. Typically, there were four inflow pipes, two large and two small at varying heights. The invert elevation ranged from 7.2 to 9.4 ft. The origin of the incoming storm sewer pipe, directed along the main road and emptying pouring into manhole 4.2 was not clear, since the manhole upstream one of 4.2, was flowing directly into the creek, with no sewer pipe scoming from across the road to this manhole. The origin of the storm sewer pipes opening into manholes 4.3 and 4.4 could

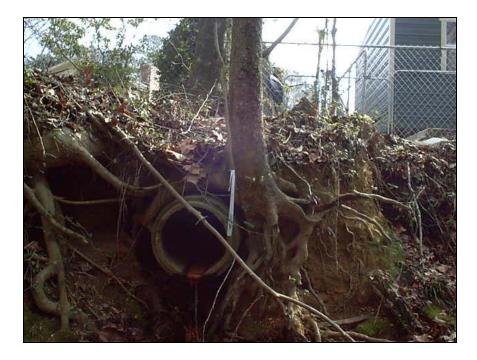
Figure 4.8. Outfall 27

4.2.3.Outfall 27: Outfall 27 is located off 25th Way East, opposite 20th St. East (Figure 4.7). The outfall is 2 ft. in diameter (Figure 4.8)

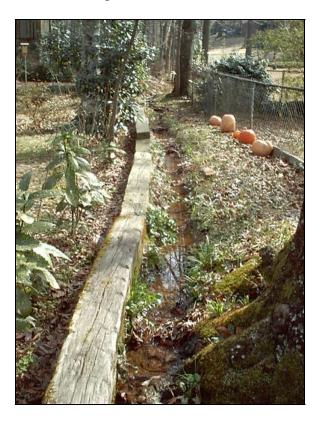
Figure 4.9. Stream Flowing into MH 27.1

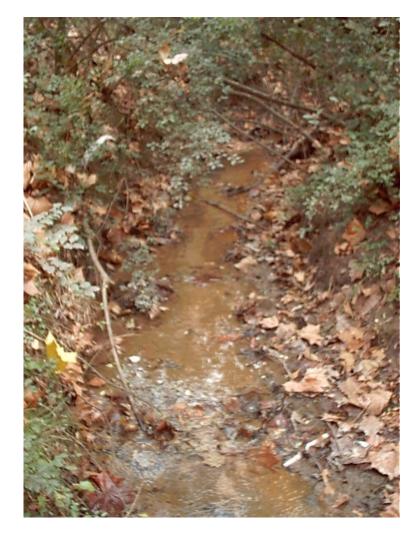
Figure 4.11. Outfall 31

The outfall is in the form of an open drainage ditch (Figure 4.11), which was traced back to flows from a manhole MH 31.1 in Figure 4.10. The open drainage ditch is 1.5 ft. across, where it flows into the creek. The invert of MH 31.1 was damaged and was connected to the drainage ditch. The drainage ditch (marked as OF 31 stream in Figure 4.10.) flows through private property for a distance of 200 ft. A 9" pipe can be seen pouring into this drainage ditch from the residence (Figure 4.12). A smaller drainage ditch was observed to join the main drainage ditch which leads to the outfall. It was

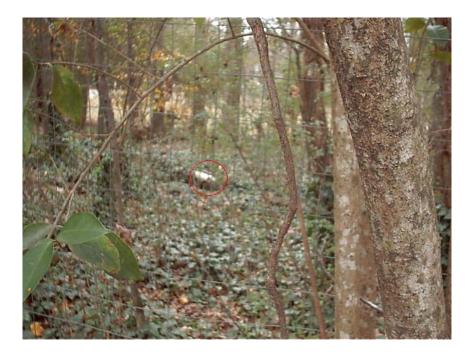
Figure 4.12. Pipe opening into ditch upstream to outfall 31

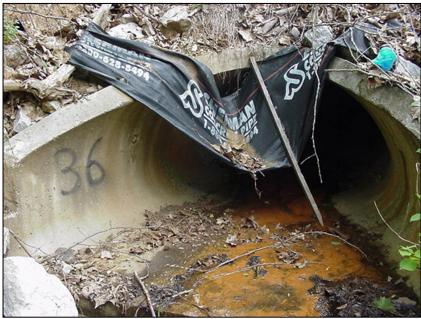
Figure 4.14. Outfall 36

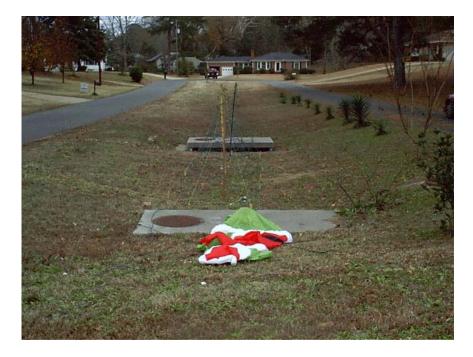
Figure 4.17. Residences Upstream to MH 39.1 and MH 39.2

A resident of this locality, Mr. Simmons, who video-taped the on-going work on the storm drain system in this area, informed us that these drains could be originating upstream half a mile from this location in a residential complex called the Yorktown Commons. Manhole 39.1 is connected to a manhole in this resident's backyard. This outfall was sampled, with Mr. Simmons' permission, during the second verification sampling period.

From the above results, it can be seen that all the water flowing through this system is very likely natural spring water. This analysis was corroborated by the residents' view that numerous springs were tapped into the storm drainage when the storm drainage system was being installed. The cotton pads laid out for optical brighteners analysis did not yield any positive results.

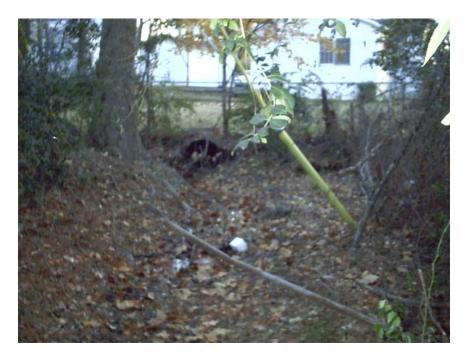
Figure 4.20. Pipe from Insurance Firm Opening into Ditch Flowing into MH 45.1

Outfall 45 is 4 ft. in diameter and is connected to an upstream manhole, which seems to be connected to a drain upstream, on the other side of McFarland Blvd. The upstream manhole , MH 45.1 has two inflow pipes, one from an open drainage ditch on the other side of the Blvd. and one coming in from upstream, along the Blvd. The pipe coming from across the Blvd. was always found to be flowing, but the pipe coming in from along the road was showing a trickling flow only in the last verification sampling period. The flow coming into MH 45.1 seems to be originating from behind a local insurance office. There is about a 18" pipe found discharging into the drainage ditch. This pipe could be the source of the washwater predicted at the outfall. No pipes were found originating from the Midas automobile repair shop, located along the upstream ditch.

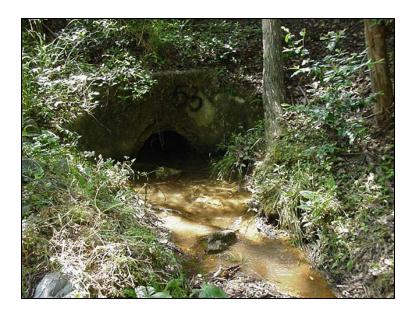
Figure 4.22. Outfall 53

4.2.8. Outfall 53: Outfall 53 is located on the edge of the Willow Trace Court Apartments property, as shown in Figure 4.21. This outfall is about 3 ft. in diameter and is characterized by copious continuous flows (Figure 4.22).

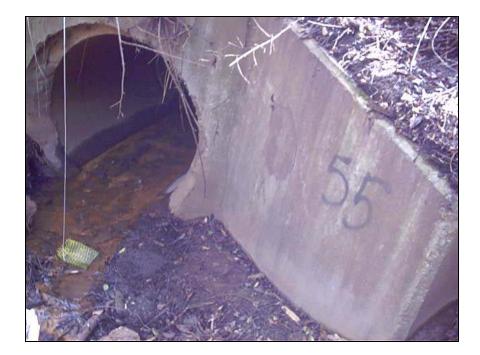
Figure 4.24. Outfall 55

4.2.9. *Outfall 55:* Outfall 55 is located a short distance from outfall 53 (Figure 4.23) and their watersheds are adjacent. Outfall 55 is also 3 ft. in diameter (Figure 4.24) and was always characterized by sediment, floatables and an unpleasant odor, characteristic of sanitary wastewater flows. This outfall was connected to manholes on the far end of the Willow Trace Court Apartments, which had drains coming in from outside the boundary of the property. Investigation further into the watershed revealed that the flows were coming in from a storm drain inlet located on 5^{th} Avenue East.

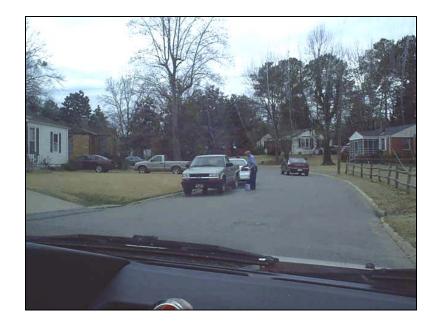
Figure 4.25. Resident washing automobile beside storm drain in area upstream to outfall 55
