Land Development and Soil Characteristics Affects on Runoff

Robert Pitt, Celina Bochis,
and Pauline Johnson

Department of Civil, Construction and Environmental Engineering
The University of Alabama
Tuscaloosa, AL 35487

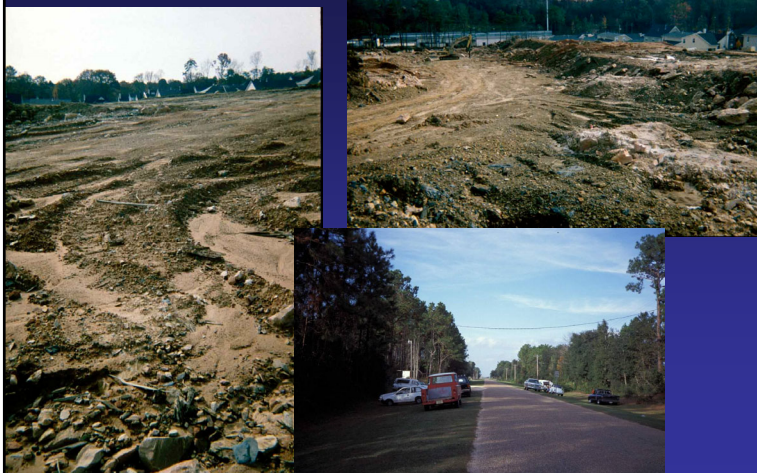
Urban Soils Compacted during and after Development

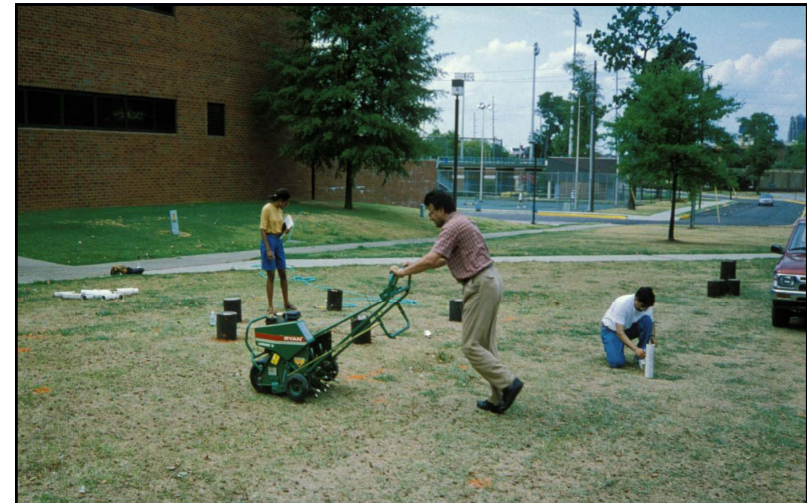
Typical household lawn aerators are ineffective in restoring infiltration capacity in compacted soils.

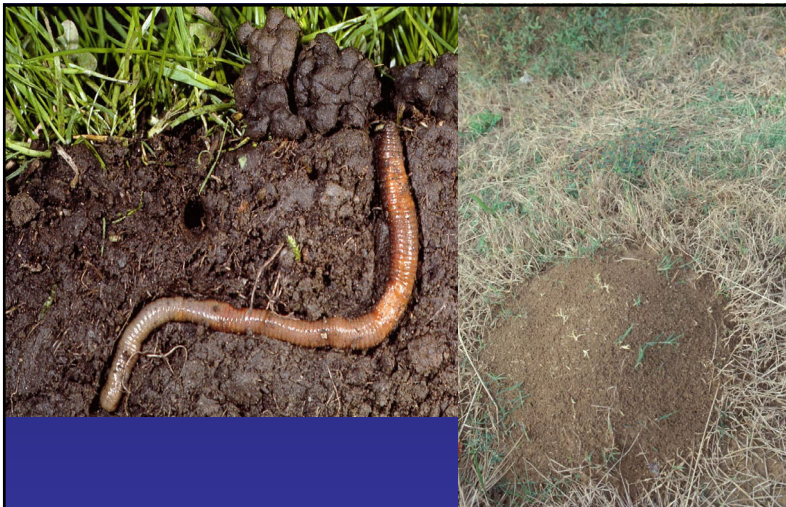
Natural processes work best to solve compaction, but can take decades.

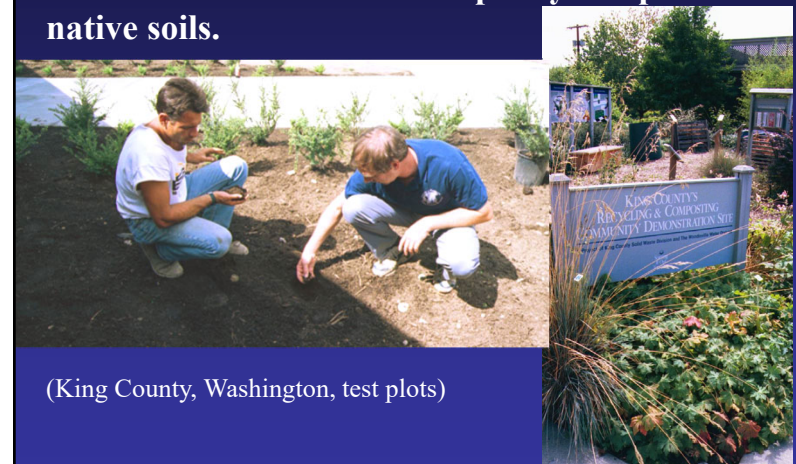
Soil modifications for rain gardens and other biofiltration areas can significantly increase treatment and infiltration capacity compared to native soils.

(King County, Washington, test plots)

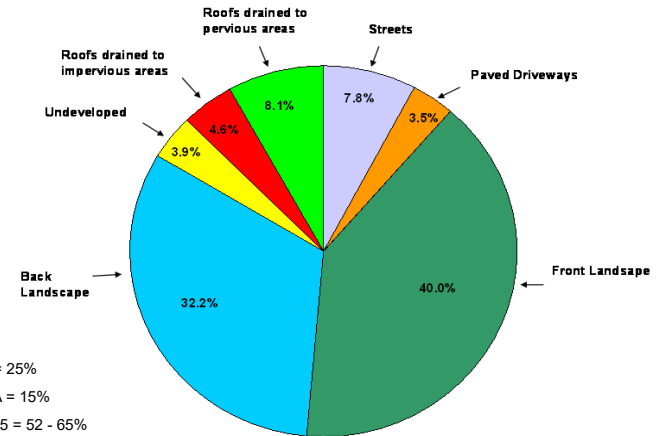
Little Shades Creek Watershed Average Land Cover Distribution High Density Residential (6 houses/acre)

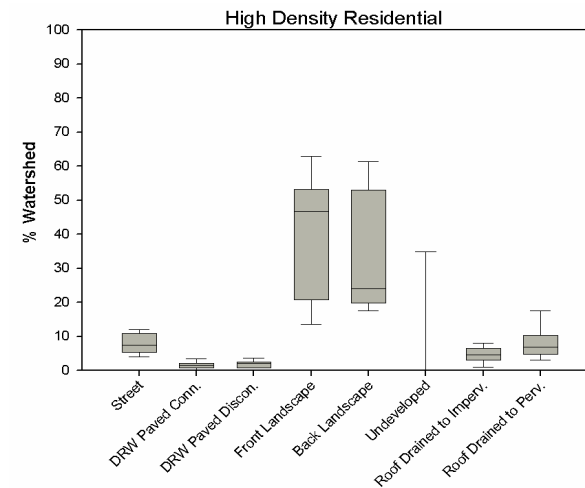
Little Shades Creek Watershed Variation in Land Cover Distribution High Density Residential

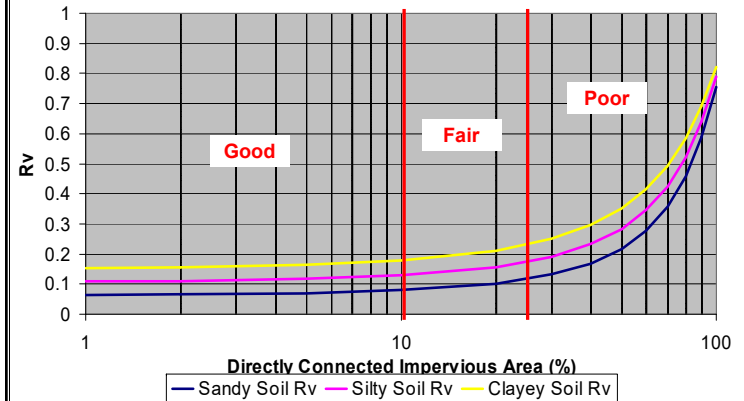
Relationship between Directly Connected Impervious Areas, Volumetric Runoff Coefficient, and Expected Biological Conditions
