## Presentation Topics

**Initial Laboratory and Field Tests for Metal and Selected Organic Releases from Building Roof Materials Conducted at Penn State - Harrisburg**

## Outdoor Asphalt Aging Tests

### Laboratory Material Leaching Tests

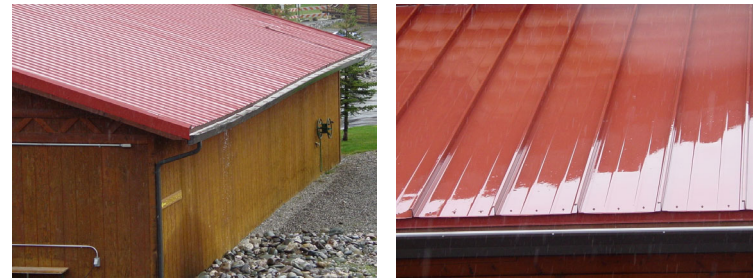
Galvalume roofing panels used on a building in Denali, Alaska

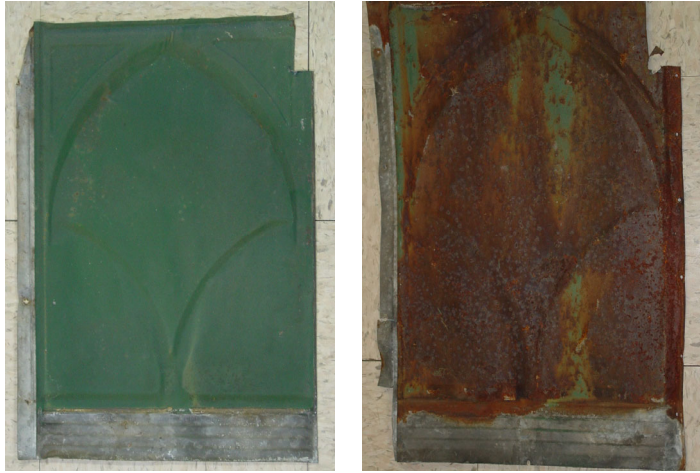
### Aged Roofing Panels

- pH, conductivity, and COD values showed little variability between storms).
- Physical degradation of roofing panels, particularly the metal panels, is visible after two weeks of exposure.

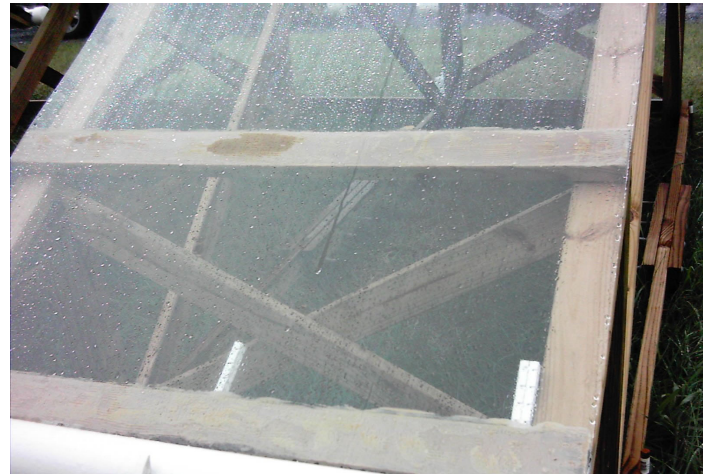
31

### During Rain Storm, August 2005

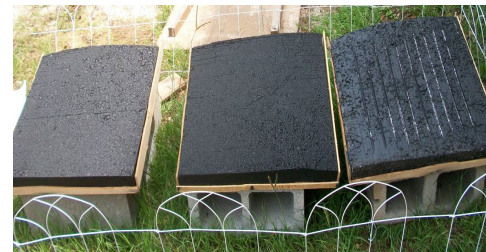
- The standard test slabs have a surface area of 0.25 m<sup>2</sup> and are 5 cm thick, prepared for this project by the National Center for Asphalt Technology (NCAT), at Auburn University, in Auburn, AL.
- The pavement slabs were set up outdoors and exposed to sun and rains, therefore being aged under natural conditions.
- An equivalent 0.5 in rain (using prior collected roof runoff) was used to obtain runoff on each of the pavement slabs periodically during the exposure periods.
- The resulting runoff was analyzed for contaminants and toxicity levels.

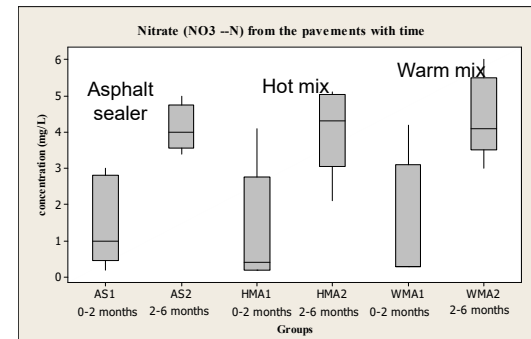
### Nitrate Concentrations in Pavement Runoff

Asphaltic Sealant (AS)	0.020
Hot Mix Asphalt (HMA)	0.037
Warm Mix Asphalt (WMA)	0.060

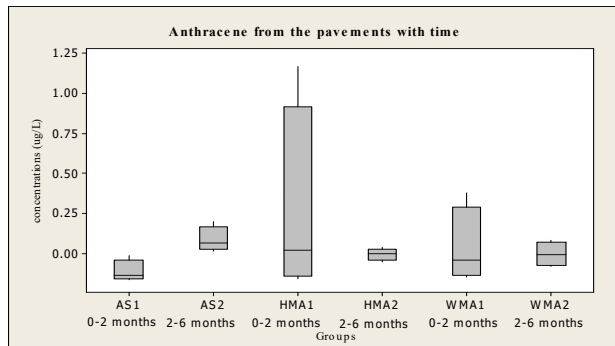
No significant differences were observed for the remainder of the PAHs analyzed based on the Kruskal-Wallis one-way ANOVA tests. However a Mann-Whitney test on the two exposure periods showed a significant difference for Anthracene.

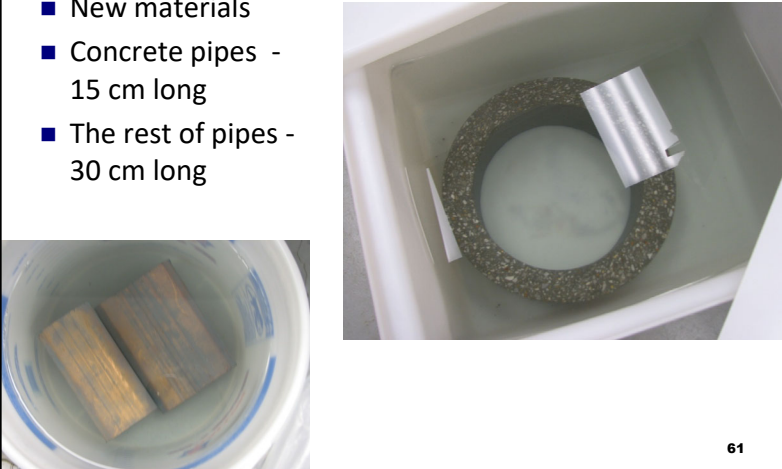
- New materials
- Concrete pipes - 15 cm long
- The rest of pipes - 30 cm long

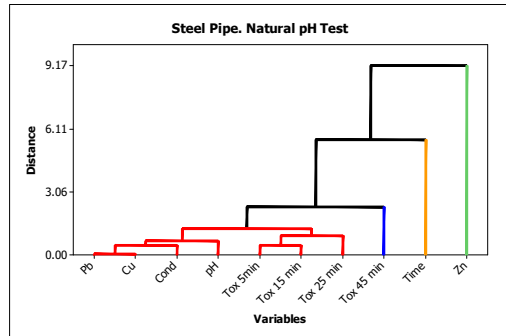
## Cluster Analyses

- For each pipe and gutter material using the data for buffered and natural pH tests.
- For the same data that were used to compute the correlation matrices
- To identify more complex relationships between the parameters.

- pH and time of exposure affected the Pb, Cu, and Zn releases.
- Pb, Cu, and Zn concentrations were highly correlated with conductivity for all materials.
- Metal releases, conductivity, pH, and time of exposure all influence the toxicity.

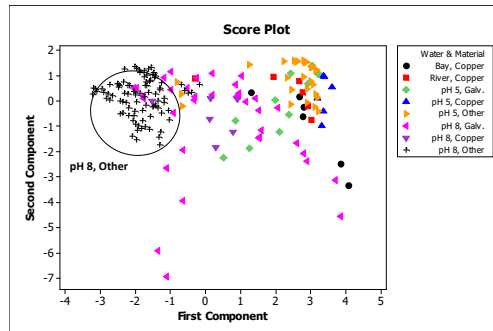
## Principal Components Analyses

- PCA was performed for all samples
- Score plot of the first two Principal Components shows groupings of samples having similar water quality characteristics.
- 1st PC (toxicity) accounts for 57% of the total variance in the data.
- 2nd PC (Pb, Zn, and time) accounts for the next 12% of the total variance.

- Mostly concrete, PVC, HDPE, vinyl, and aluminum materials under controlled pH 8 conditions
- Low loadings of toxicity and metals
