## Day 10: Combinations of Controls used at Construction Sites

Robert Pitt, P.E., Ph.D., BCEE  
Emeritus Professor of Urban Water Systems  
Department of Civil, Construction, and Environmental Engineering  
University of Alabama, Tuscaloosa, AL

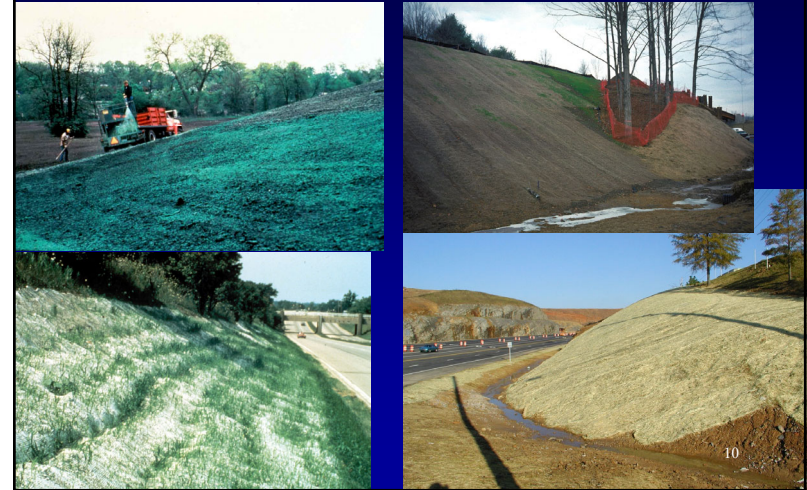
## Erosion Controls Slope Protection with Hydroseeding and Blankets

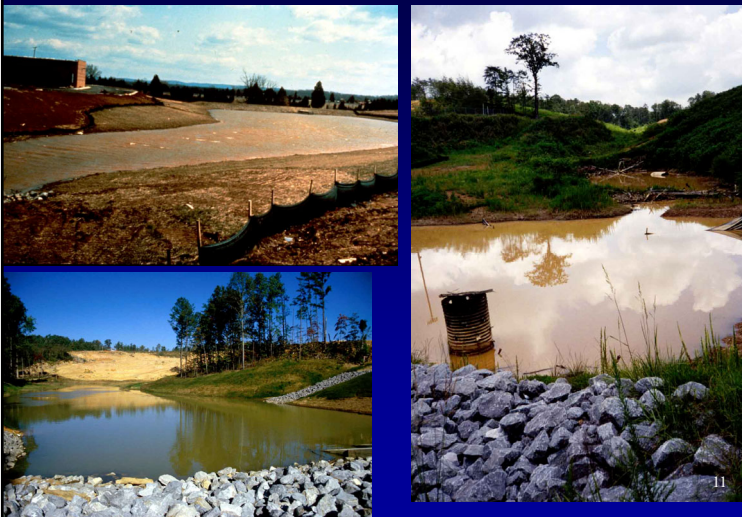
## Typical Construction Sediment Ponds

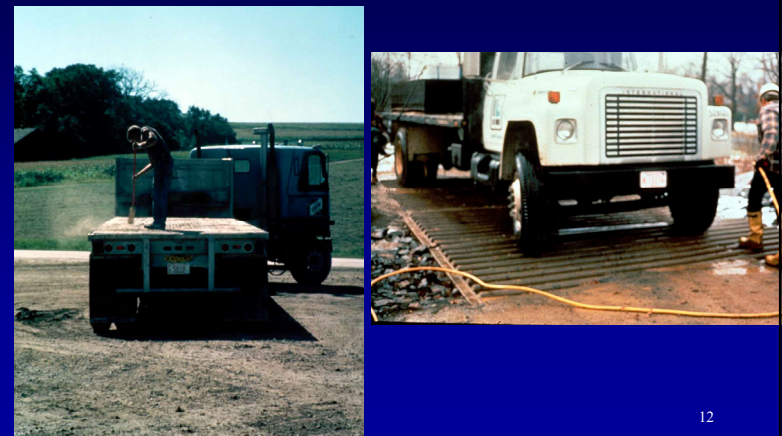
## On-Site Good Housekeeping Controls Vehicle Cleaning

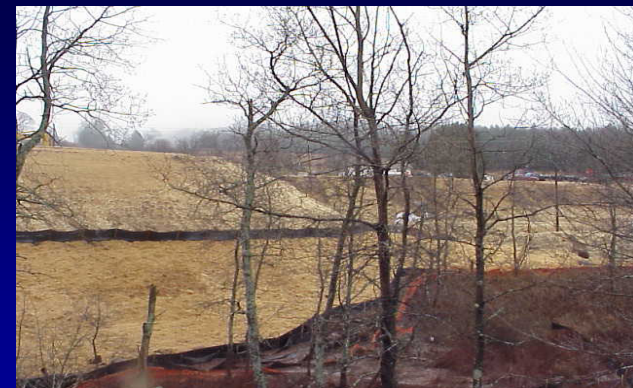
North facing fill slope just south of the Parksville project offices (D. Lake photo)

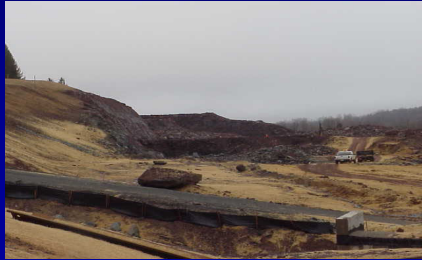
Excavated slopes in the project area. This material is taken to the waste area (D. Lake photo)

- Construction began in 2009 and was well underway by the time poor weather arrived in late fall. The offsite waste area had been divided into seven cells to receive the excess excavated material.
- Two sediment basins were located in the front portion of the waste area.

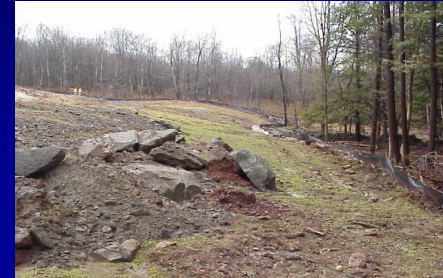
Excess excavation deposited in a forward cell of the waste area when haul road became impassable (D. Lake photo)

- Winter conditions began early and construction continued.
- The trucks hauling the waste soil material could not travel back far enough in the waste area to reach the cell locations where they were to dump.
- They began dropping their loads in the front of the area filling up these forward areas.

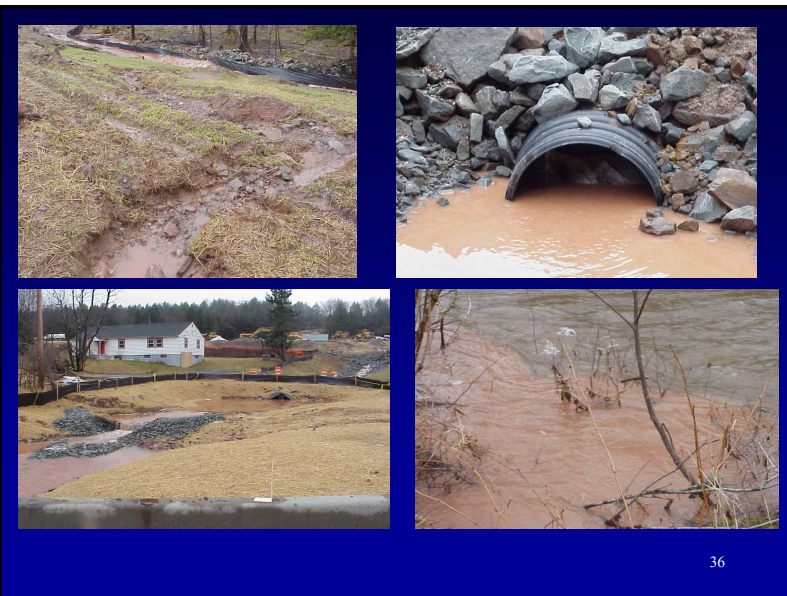
- When early spring rains came, highly turbid stormwater runoff from the waste area flowed down into the site area combining with additional turbid runoff and discharged into Little Beaver Kill Creek, a highly valued trout stream.
- These water quality violations caused the site to be shut down until the problems were corrected.
- The majority of the soils on the site contained a significant percentage of fine grained clay; some that was colloidal in character. These fine materials did not readily settle out.
- These small particles passed directly through the sand filter systems that were initially installed to capture them.
- This fine material also plugged geotextile fabrics that were placed around perforated sediment basin outlet pipes. This caused runoff to overtop the west sediment in the waste area, eroding a significant portion of the dam.

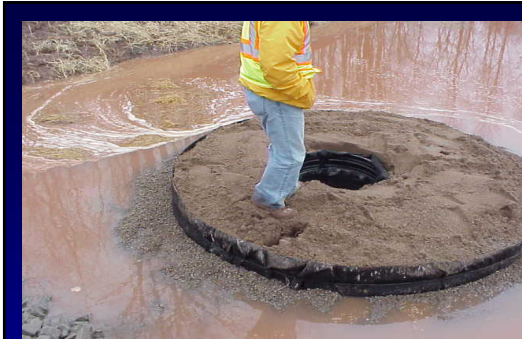
A sand filter constructed around a vertical dewatering riser in a sediment basin within the project site (D. Lake photo)

Turbid flow moving through the sand filter system, entering the perforated outlet pipe which discharges to a drainage swale offsite (D. Lake photo)

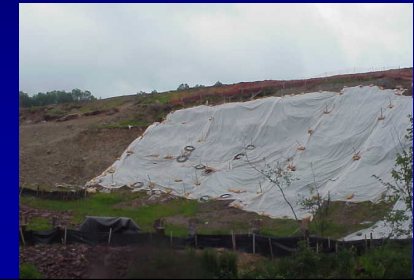
Steep slope at Parksville on-ramp construction covered with plastic to prevent erosion into the Little Beaver Kill (D. Lake photo)

- Steep slopes, poor soils and large exposed areas create challenges for site management.
- The sequence of construction and phasing plan should be adjusted to limit the risk at the site.
- It may even be necessary to cover very steep exposed areas with plastic or geotextile until final grading and stabilization are completed.
- Polymer systems should be evaluated for application particularly if the soils on the site are highly colloidal.
- Good site control begins with a comprehensive evaluation of the site's character and recognizing the possible problems that could occur during construction.
- The Stormwater Pollution Prevention Plan (SWPPP) should be designed accordingly and maintained with appropriate personnel responsible for its daily implementation and inspection.

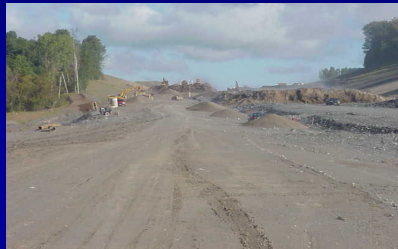
Construction equipment is removing previously placed embankment material to unload the slide area north of Scoby Road. All runoff drains towards the foreground (D. Lake photo)

- A significant mile long portion of this work was planned in an area to the west of the existing route 219 and centered on a lower elevation at Scoby Road. The design for this segment was an embankment fill section.
- A landslide occurring during construction activities in the spring of 2008 altered these plans.
- The landslide was a rotational failure that covered an area approximately 0.75 miles long and up to 600 feet in width from the top of the scarp on the east side to the toe of the slide on the west side.

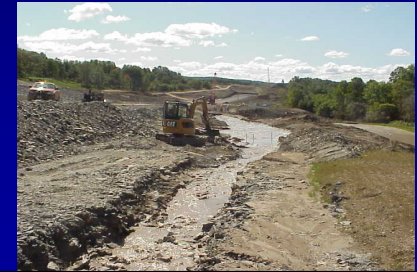
Groundwater is flowing in the drainage ditch along the west side of the construction area towards Scoby Road. The flow rate from this source was a fairly constant 130 gallons per minute (D. Lake photo)

- The construction right of way limits were relatively narrow for the original design and in the slide area these limits had to be extended with additional properties taken to affect a stable remedy. These narrow limits also constrained erosion and sediment control options and made stormwater runoff control difficult.
- To complicate matters further, groundwater became a large problem as soon as the excavation for the revised design was down twelve feet or so below natural ground.

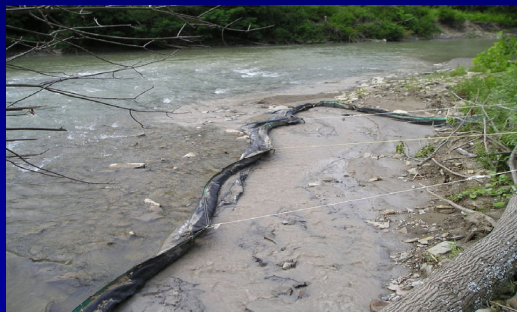
Turbid discharge is shown here entering Cattaraugus Creek at the Scoby Road outlet approximately 400 feet to the west and down slope of the project limits (D. Lake photo)

- The existing erosion and sediment control measures that were in place in the Scoby Road segment consisted of perimeter silt fence, intermittent stone check dams and two sediment basins.
- These, however, were not effective in preventing turbid discharges from leaving the project boundary.

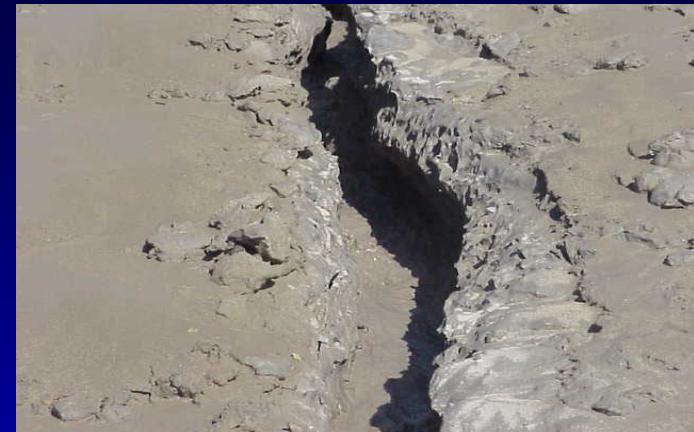
The soil north of Scoby Road is low plastic clay. Here it is being rapidly eroded by groundwater (D. Lake photo)

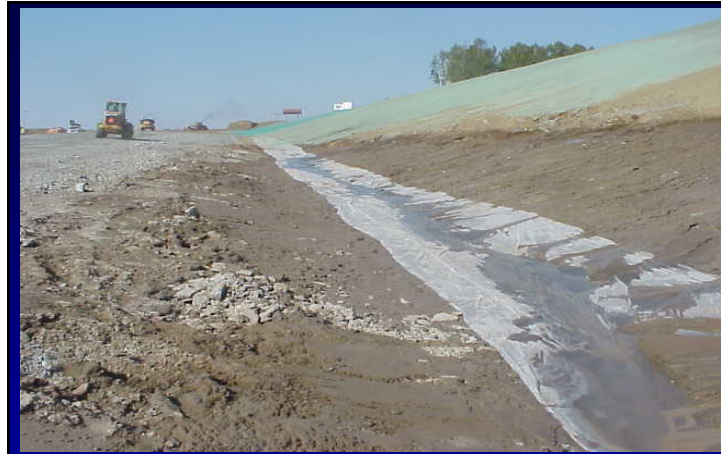
The plastic lined swale conveys groundwater through areas of fine grain soil limiting the erosion. Note the slope stabilization (D. Lake photo)

- A revised erosion and sediment control plan was developed to limit the amount of exposed fine grain soil, provide stable conveyance for surface flow using one inch of runoff for design, and locate and design additional sediment trapping devices.
- Polymer treatment (Chitosan Acetate) was added as a final settling stage for the fine particles north of Scoby Road.
- The erosion and sediment control plan was revised weekly as the work progressed in the slide area.
- Practices were relocated, added and removed as the excavation and fill process continued.
- Ditches and swales were lined with construction grade plastic to prevent flow from eroding the fine grain soil.
- Stone check dams were placed in drainage ways and faced with pea gravel to slow velocity and trap sediment.

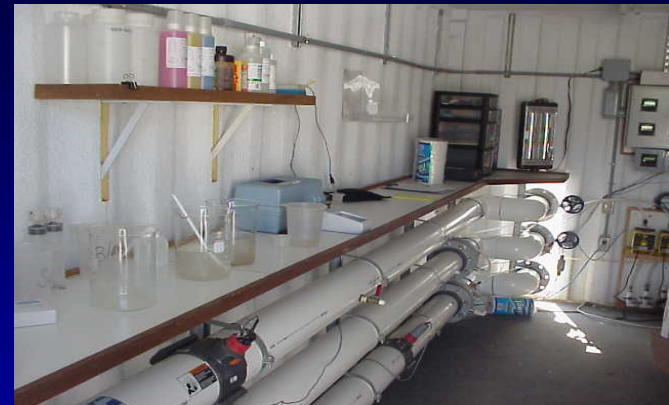
Control center for the polymer operation. Constant monitoring of the NTU levels is provided by the continuous turbidity meters on the back wall (D. Lake photo)

- The erosion and sediment control system north of Scoby Road terminated at a sediment pond from which the remaining turbid water was treated by a polymer treatment system.
- The designed dosage of Chitosan Acetate (average metered dose was 0.86 lb/day, or about 0.7 mg/L), the flow passed through settling tanks, and released to Cattaraugus Creek.
- The background NTU reading for the creek was an average of 5 NTU. The average discharge from the system was 1 NTU.
- Effluent sediment and turbidity below natural conditions can cause unstable receiving water conditions if the water is too far below its carrying capacity. This can increased stream bank erosion and sediment transport in the receiving water.

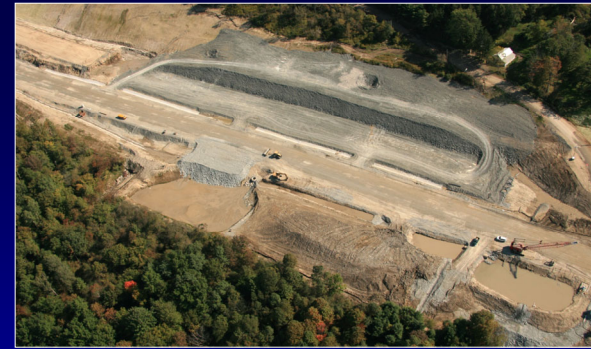
This aerial view shows the erosion and sediment control system just north of Scoby Road located at the right of the photo. Note the plastic lined swales. Flow is from left to right as it works from a swale through a pipe to the linear sediment trap, the small basin with a pipe to the larger basin where the polymer system is located. The shale buttressing for slope stability and drainage is prominent in the upper portion of this part of the project (NYS DOT photo)

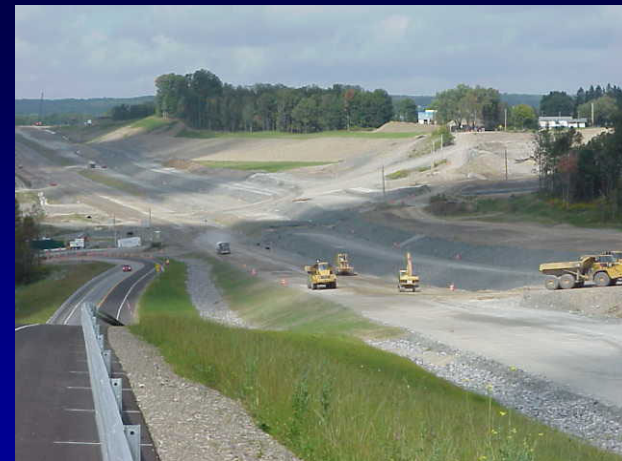
Final grading for the pavement base layer is almost completed in the Scoby Road segment (D. Lake photo)
