Day 7: Design of Stable Slopes at Construction Sites

Robert Pitt, P.E., Ph.D., BCEE
 Emeritus Cudworth Professor of Urban Water Systems
 Department of Civil, Construction and
 Environmental Engineering
 University of Alabama
 Tuscaloosa, AL

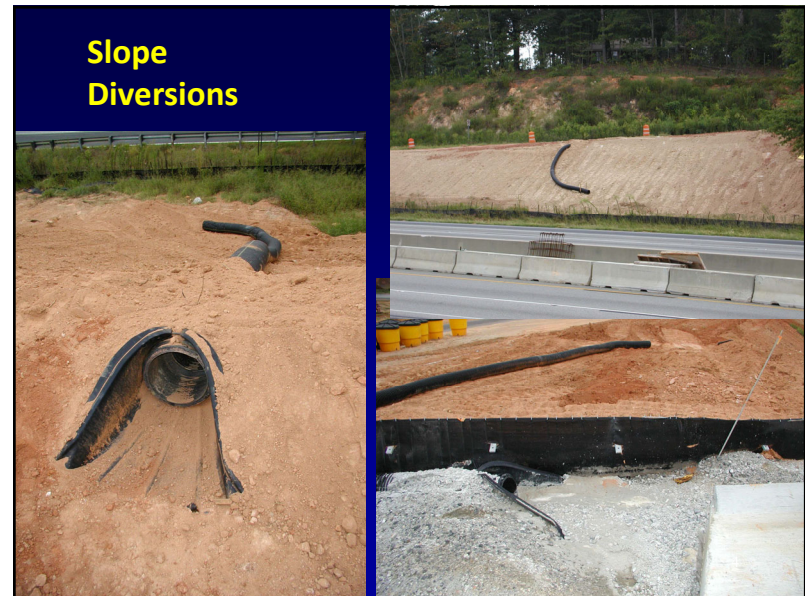
Slope Diversions

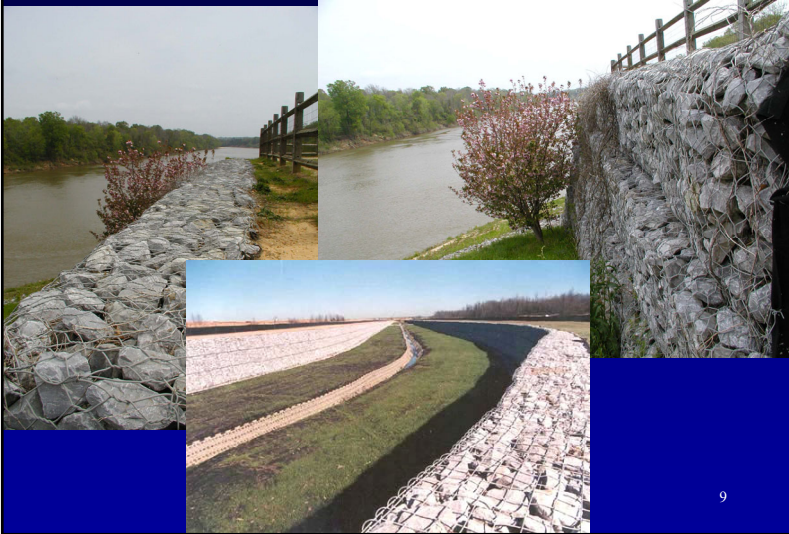
Gabions for Slope Protection Retaining Walls

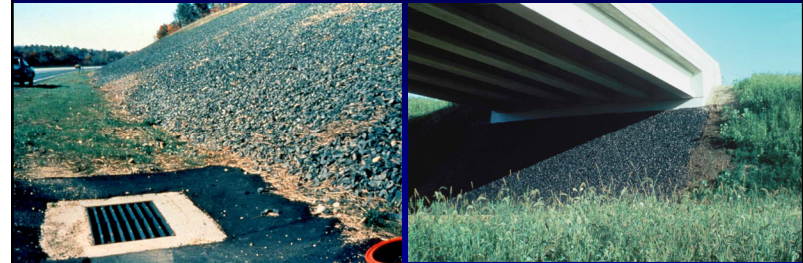
Slope Protection Using Different Materials

Rock and Asphalt for Shaded Areas

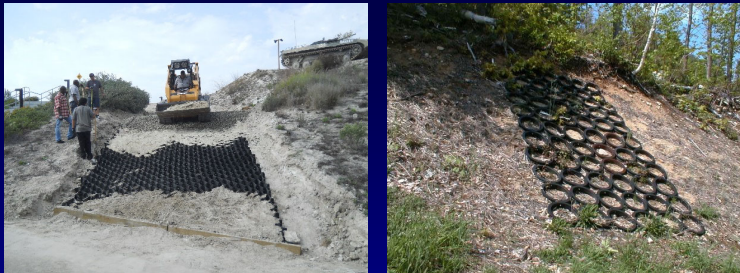
Mechanical geoweb and other material (even old tires) for biotechnical slope protection (will be planted for slope stability, or interfiled with sand for road)

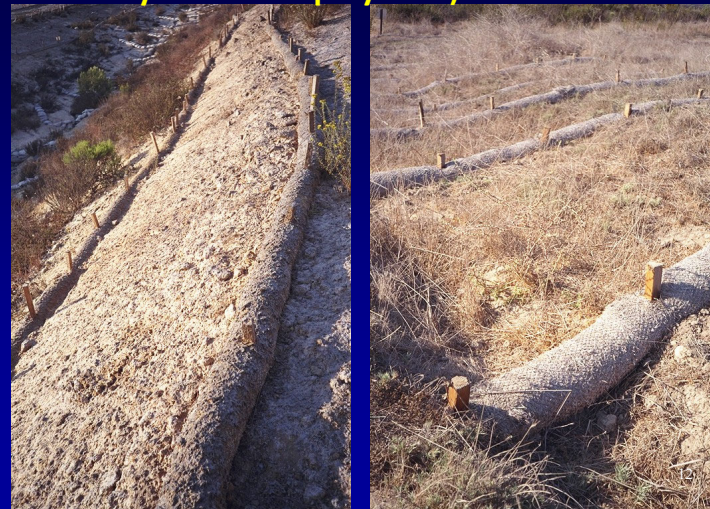
Coir Logs with Hydromulch Binder (can also be effectively used with polymers)

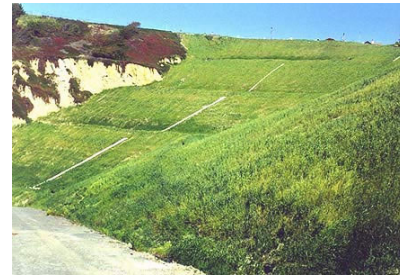
Many mats that have this C factor for this slope condition (all except S75). In this example, the selection of a mat having an n of 0.067, or greater will be difficult. Most mats are in the range of 0.022 to 0.055. It will therefore be necessary to use filter fences, coir logs, or other methods to provide additional flow resistance to the flow on this slope. Alternatively, the slope length can be shortened with a bench and diversion.

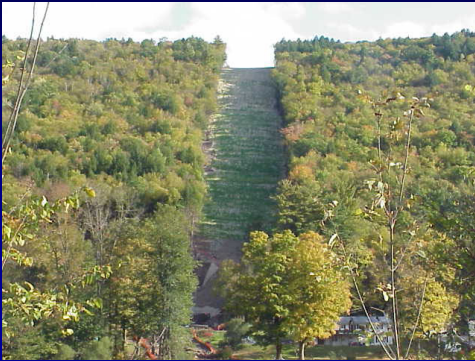
Peas Eddy slope stabilized with slope breakers and seeding with a double layer of jute mesh over straw mulch over the entire slope face (D. Lake photo)

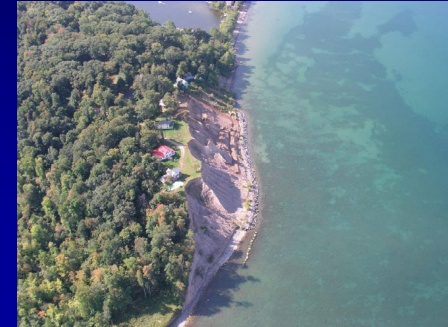
Case History on Steep Slopes, Lake Bluff Slope Stabilization

- Lake Bluff is located on the southern shore of Lake Ontario, adjacent to Sodus Bay, halfway between Rochester and Syracuse, New York.
- At present, the edge of Lake Bluff is over 80 feet above the lake surface and has been estimated to be receding at an average rate of four feet per year.

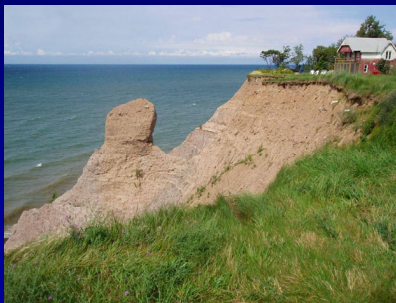
A toe revetment was constructed that combined off-shore and on-shore components. The off-shore section was a sloping rock blanket of 3,000 pound stone with a 5 foot wide crest approximately 5 feet above mean water level. The on-shore section was built of stone weighing 2,500 to 3,000 pounds with a 4 foot wide, 4 foot thick berm just below the normal water line and running up the shoreline to an elevation 8 feet higher on the 2 to 1 constructed slope.

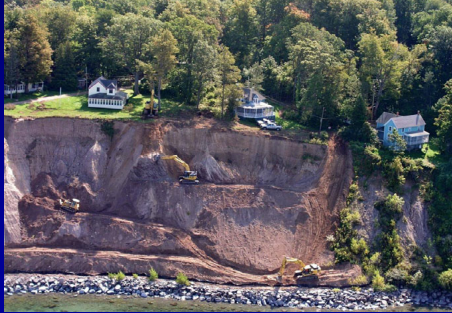
- Groundwater seeps on the face of the slope were controlled by rock slope drains tied to sub-surface outlets, while a trench drain at the top of the slope was constructed to intercept shallow groundwater and capture surface flows and divert them around the slope face to a rock lined waterway.

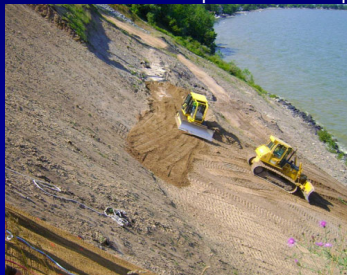
- The sequencing of the slope construction can be seen in this photo.
- Rough grading and drainage installation has been completed with some still evident at the top of the picture.
- Finish grading is occurring in the middle while below that the jute matting is being placed on the slope and anchored.
- The dark area at the bottom of the picture is the seed and compost mix that has been pumped onto the slope

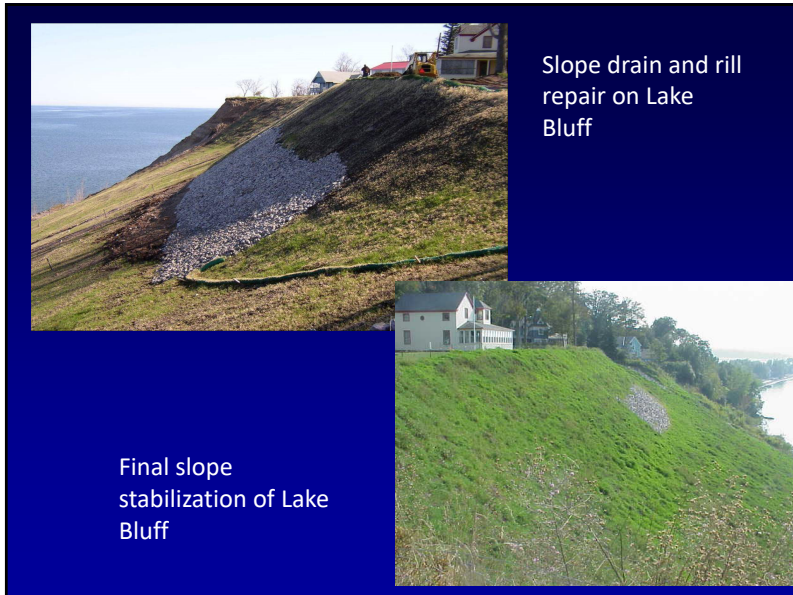
Slope drain and rill repair on Lake Bluff

Final slope stabilization of Lake Bluff

- Initial results were very good. The entire slope face germinated a dense seeding. However, in the spring 2010, some surface sloughing did occur as a result of snow pack melt water and additional seeps on the slope. Slope repair commenced as soon as the slope was dry enough for access. Sloughed areas were excavated and stone weep drains were installed. The linear sloughs were re-graded, seeded and mulched with anchor netting placed over the top.
- Further stabilization was provided by placing live willow stakes driven into the damp slope areas. As these root the plants will provide a reinforcement to the soil while its transpiration will help keep the slope drier.
