Evaluation and Demonstration of Stormwater Dry Wells and Cisterns
in Millburn Township, New Jersey

by Robert Pitt and Leila Talebi
The University of Alabama
Tuscaloosa, AL 35487

EPA Contract: EP-C-08-016

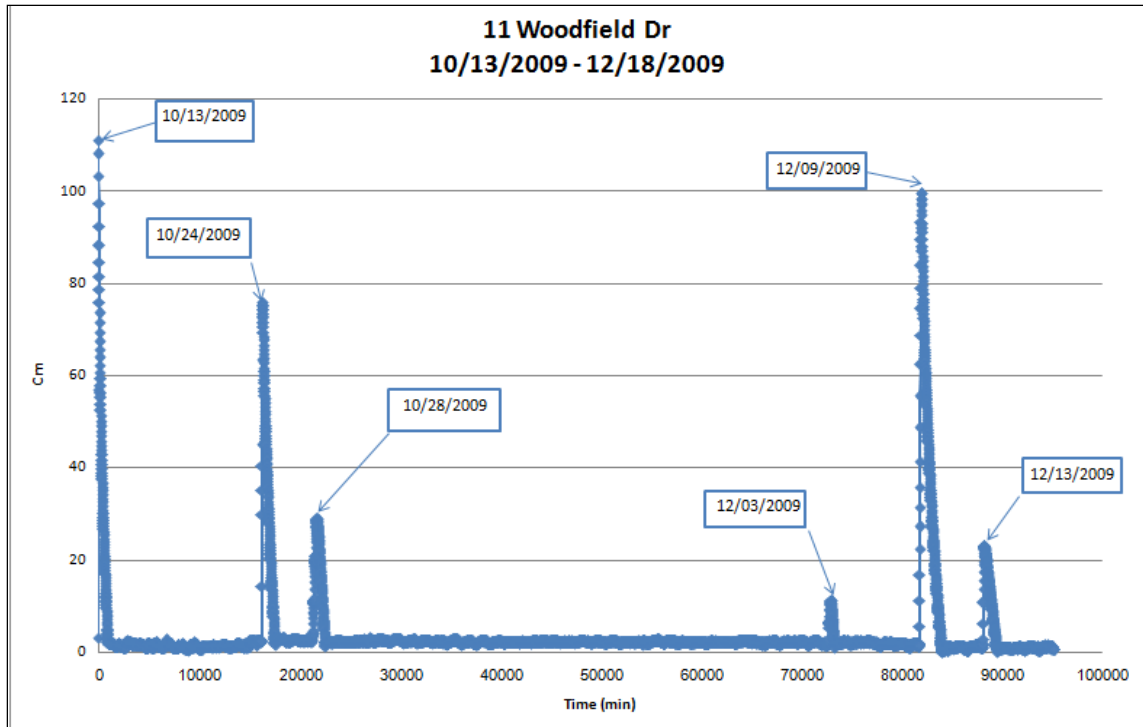
Figure 1-3. Time series example of dry well water levels for a two month period at 11 Woodfield Dr.

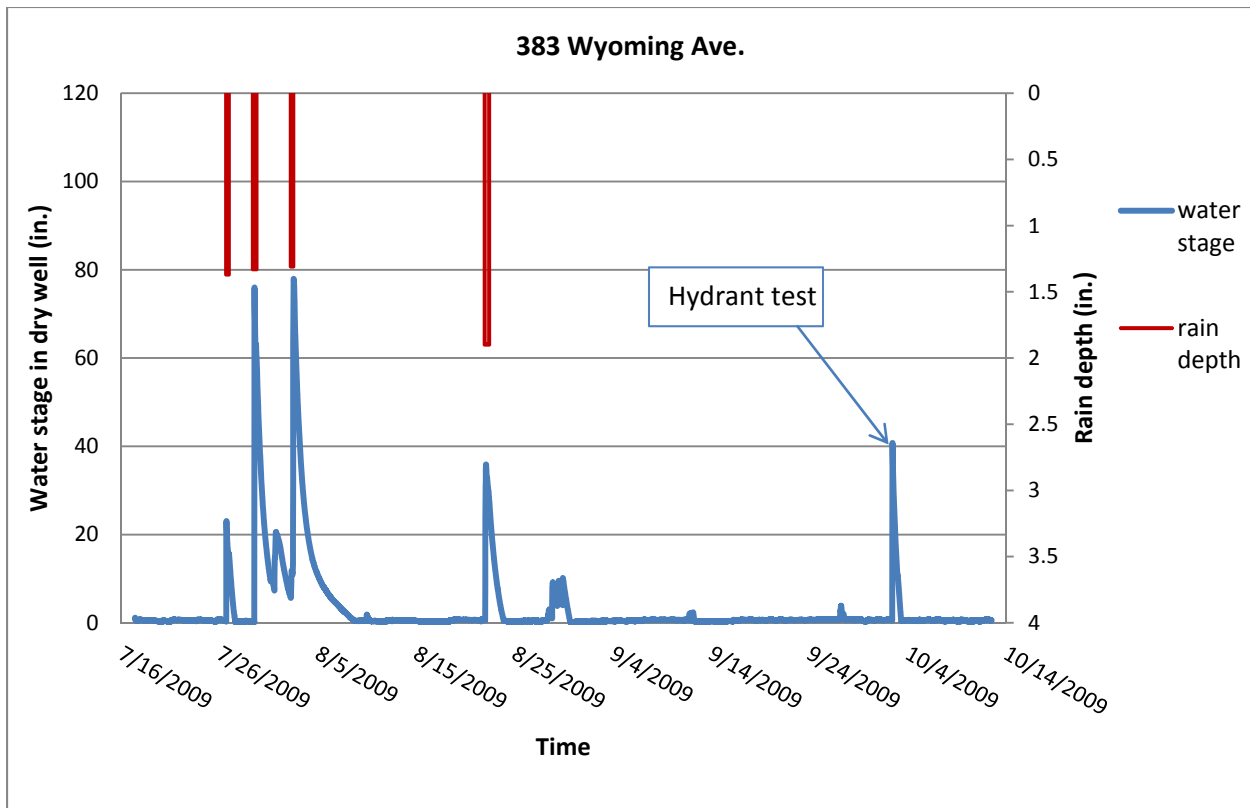
Figure 1-5. Example of site with good draining dry well.

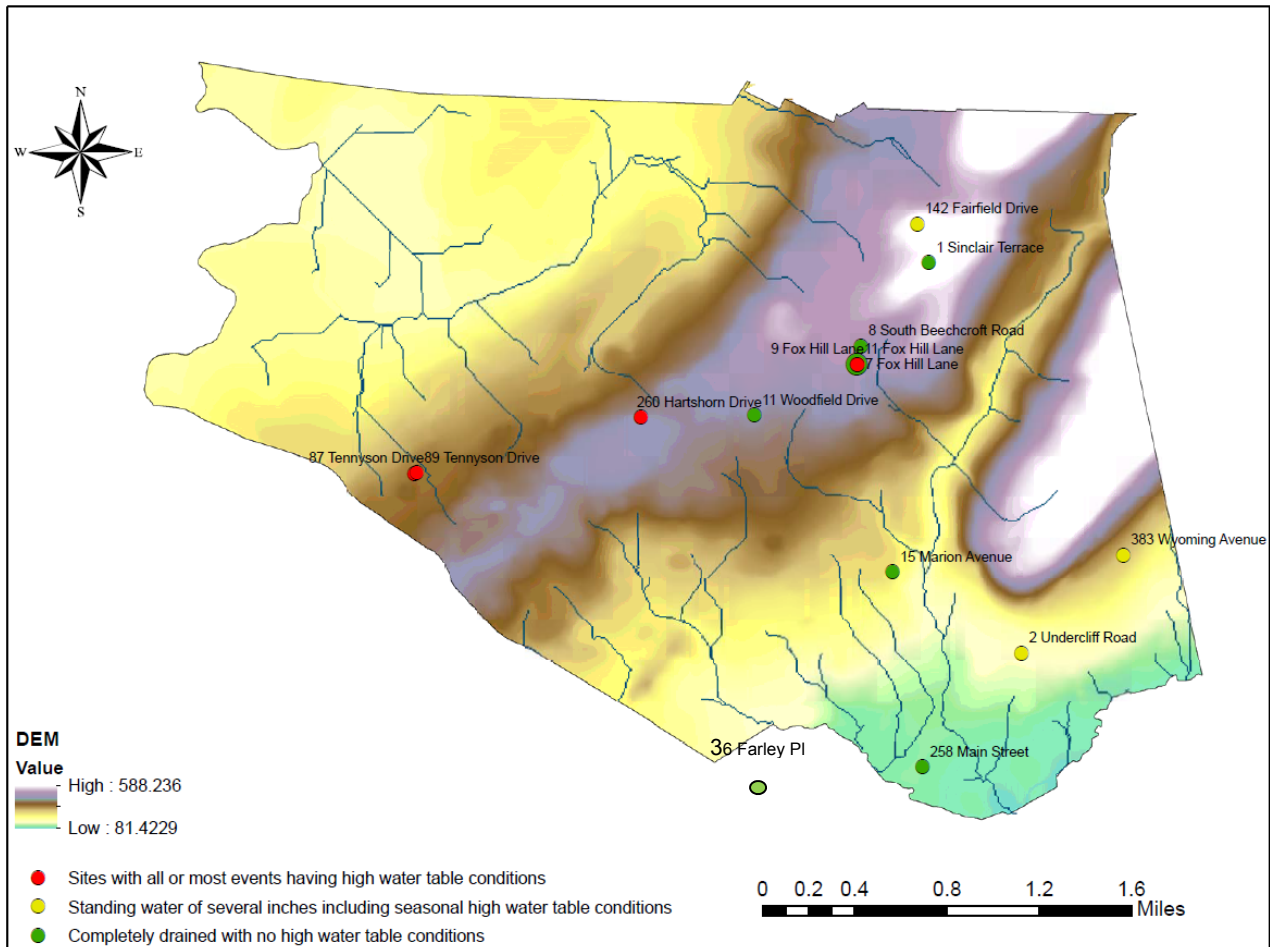
Therefore, even though the site conditions met the design guidance, some locations still had standing water. It is likely that seasonal (or possibly long-term) high water tables occurred at some of the locations. The lack of site specific groundwater depth information did not allow this to be verified, but the performance of some of the drain-down curves supports this finding.

the headwaters). The sites that had high standing water long after the events ended had substantially reduced infiltration rates. In the analyses, these rates were considered to be the constant (final) rates observed, with no initial rate data or first-order decay Horton coefficients used (relatively constant, but very low infiltration rates). Three of the sites had severely degraded infiltration conditions (260 Hartshorn, 87/89 Tennyson, and 7 Fox Hill). These sites all received runoff from the entire property or from multiple impervious areas (and are 1 to 5 years old). It is not known if the source water or groundwater conditions affected the drainage conditions at these sites. Dry wells receiving runoff from all impervious areas would have a greater silt load and likely clog prematurely compared to sites only receiving roof runoff.

Figure 1-7. Township map showing locations having varying standing water conditions in monitored dry wells.

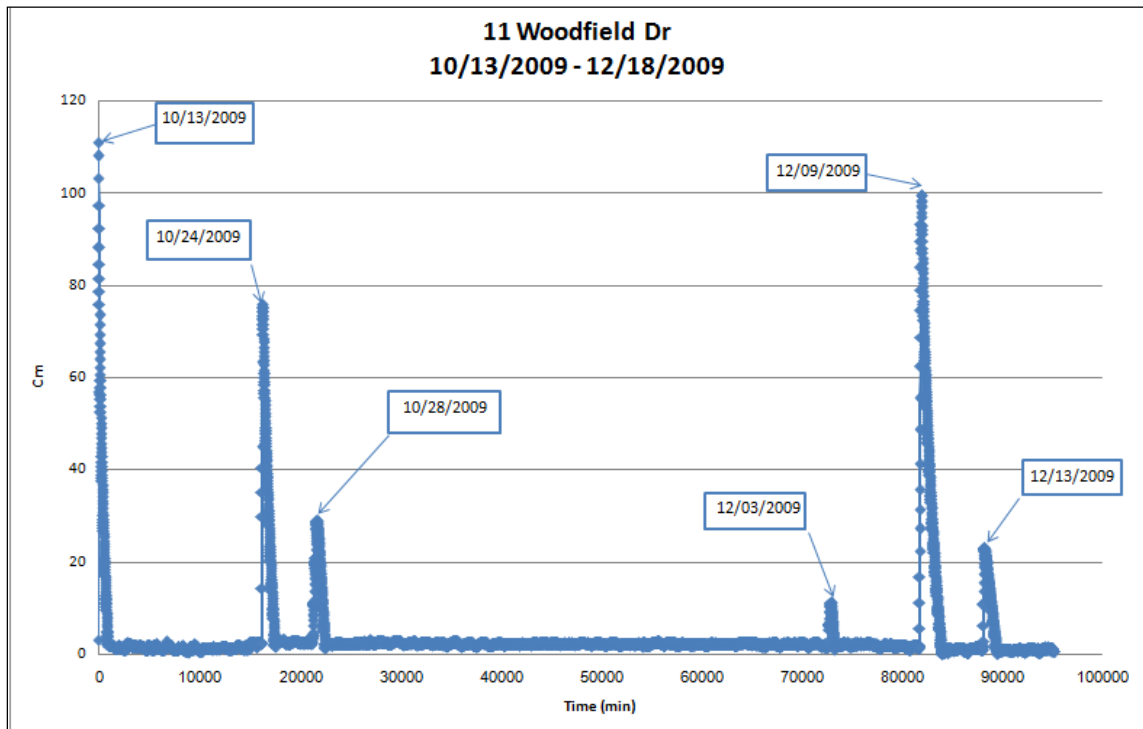
The first step in the data analyses was to plot the data as time series. Figure 5-1 is an example time series plot of the water levels recorded over a two month period at 11 Woodfield Dr. showing 6 separate events (the first peak only shows the dropping water levels from the Oct 13, 2009 event). The infiltration characteristics of the dry well installations were calculated from the recession cures of these individual rain events. The infiltration rates for each 10 minute step were calculated based on the drop in water level per increment, resulting in plots of infiltration rates vs. time since the peak water

Figure 5-1. Time series example of dry well water levels for a two month period at 11 Woodfield Dr.

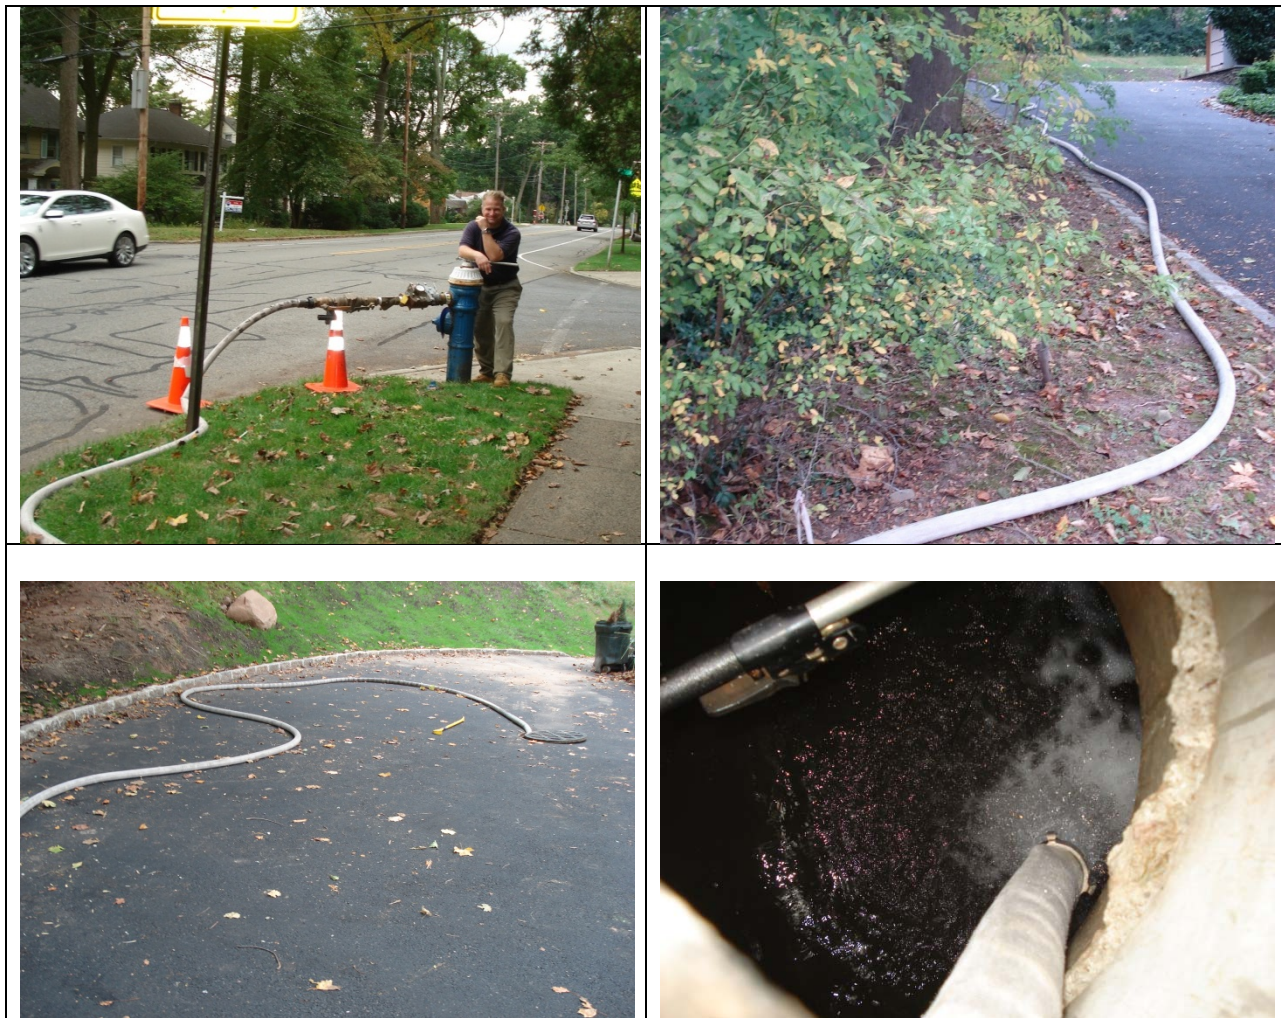
Figure 5-5. Infiltration studies for a dry well located at 383 Wyoming: rapidly filling the dry well with water from the fire hydrant and recording the fall of water level.

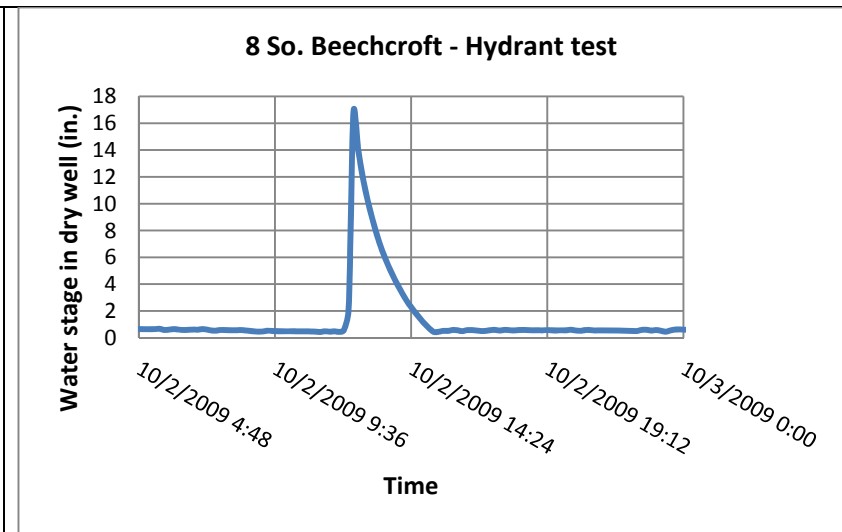
8 So. Beechcroft - Hydrant test

3 hr total drainage time (only half full as too rapid infiltration to fill dry well to full depth)

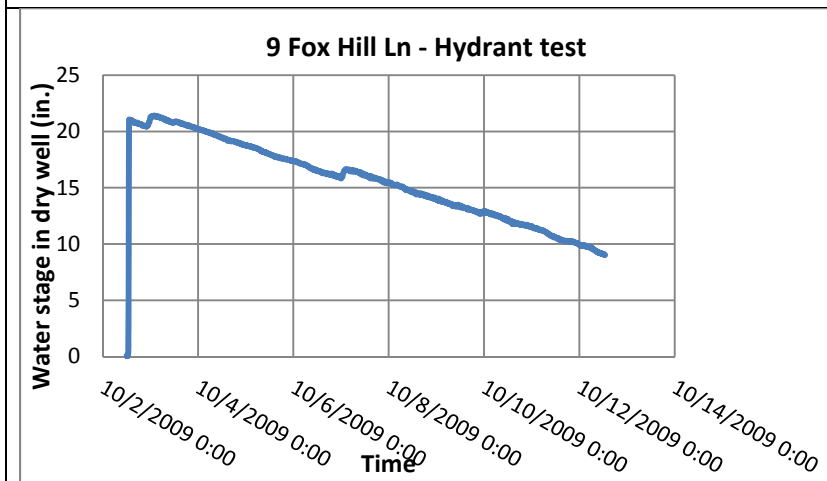
9 Fox Hill Ln - Hydrant test

About 20 days total drainage time (extrapolated as rains interrupted test)

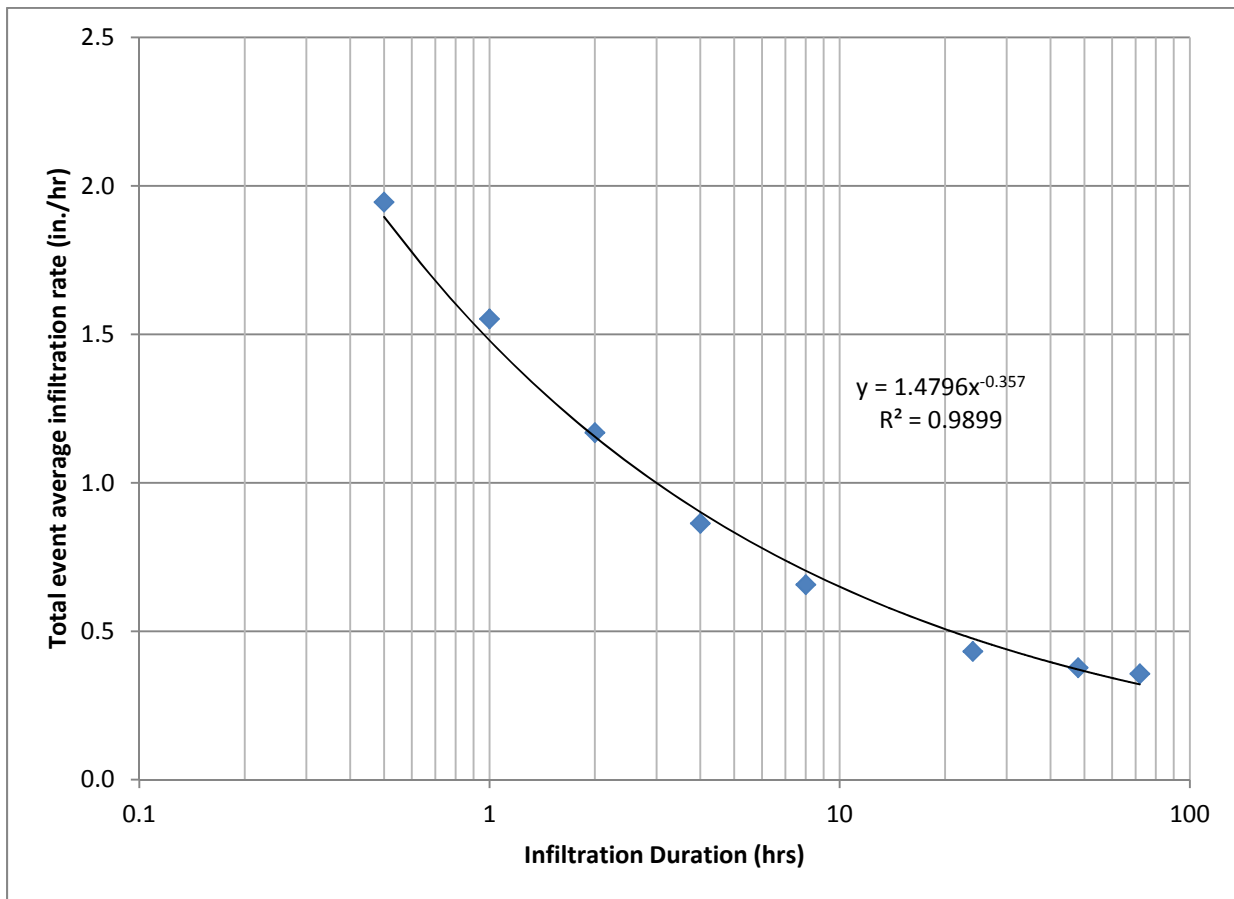
Figure 5-20. Infiltration rates averaged over event durations for C and D surface soils and poorly-drained A and B subsurface soils having extended standing water. (1 in./hr = 25.4 mm/hr)

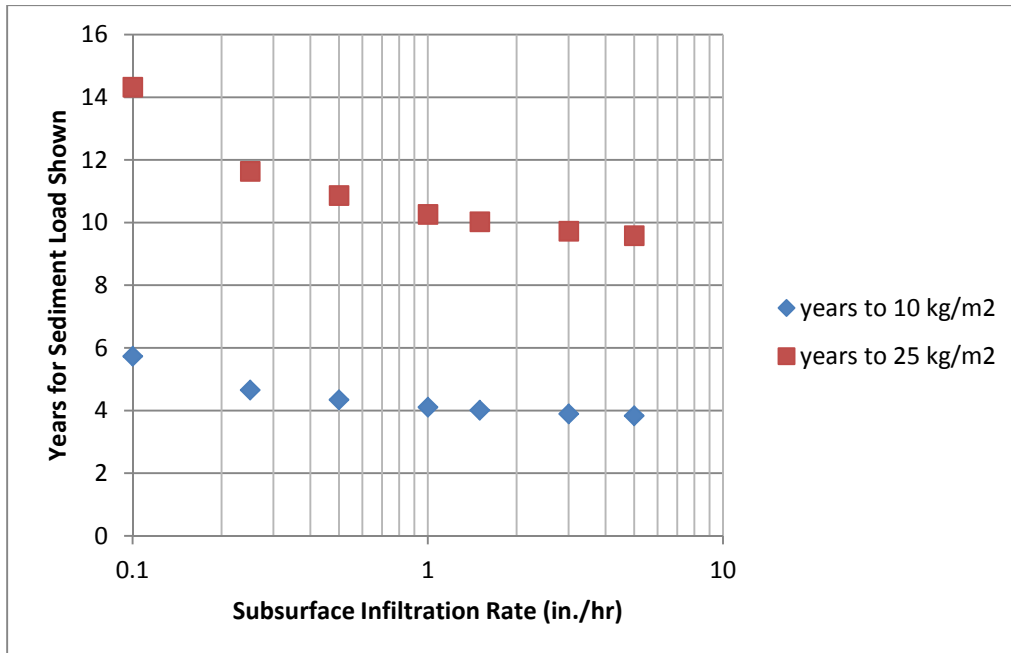
Figure 7-10. Clogging potential of dry wells in Millburn, NJ. (1 in./hr = 25.4 mm/hr)

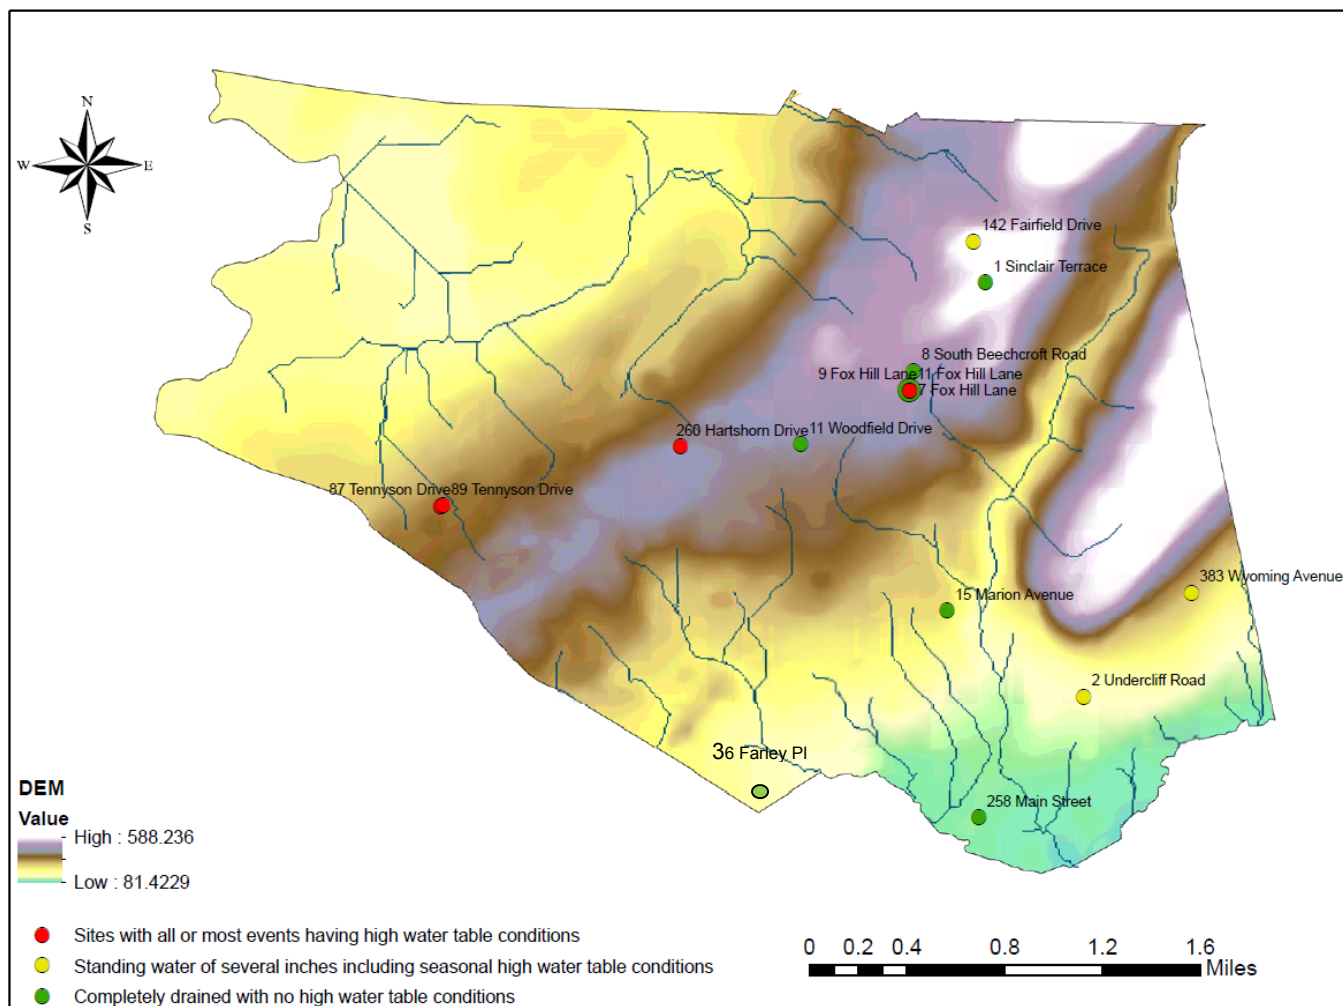
Figure 8-1 is a map showing these general conditions for Millburn. Most of the monitored dry wells were along a ridge between the two main drainages of the township, with no obvious pattern of high water conditions, except that the high standing water dry wells were located along a line to the southwest along the ridge and are located fairly close to headwaters of streams (high water tables were noted in areas with nearby streams, but that was assumed to be in the larger stream valleys and not at the headwaters). The sites that had high standing water long after the events ended had substantially reduced infiltration rates. In the analyses, these rates were considered to be the constant (final) rates observed, with no initial rate data or first-order decay Horton coefficients used (relatively constant, but very low infiltration rates). Three of the sites shown in Table 8-1 had severely degraded infiltration conditions (260 Hartshorn, 87/89 Tennyson, and 7 Fox Hill). These sites all received runoff from the entire property or from multiple impervious areas (from 1 to 5 years old). It is not known if the source water or groundwater conditions affected the drainage conditions at these sites. Dry wells receiving runoff from all impervious areas would have a greater silt load and likely clog prematurely compared to sites only receiving roof runoff.

Figure 8-1. Township map showing locations having varying standing water conditions in monitored dry wells.
